# STRUCTURE NO. 04211

SOUTH PARK AVENUE  
over  
MILL RIVER  
EASTON

12 MONTH Routine & Special Inspection

on  
4/10/2014

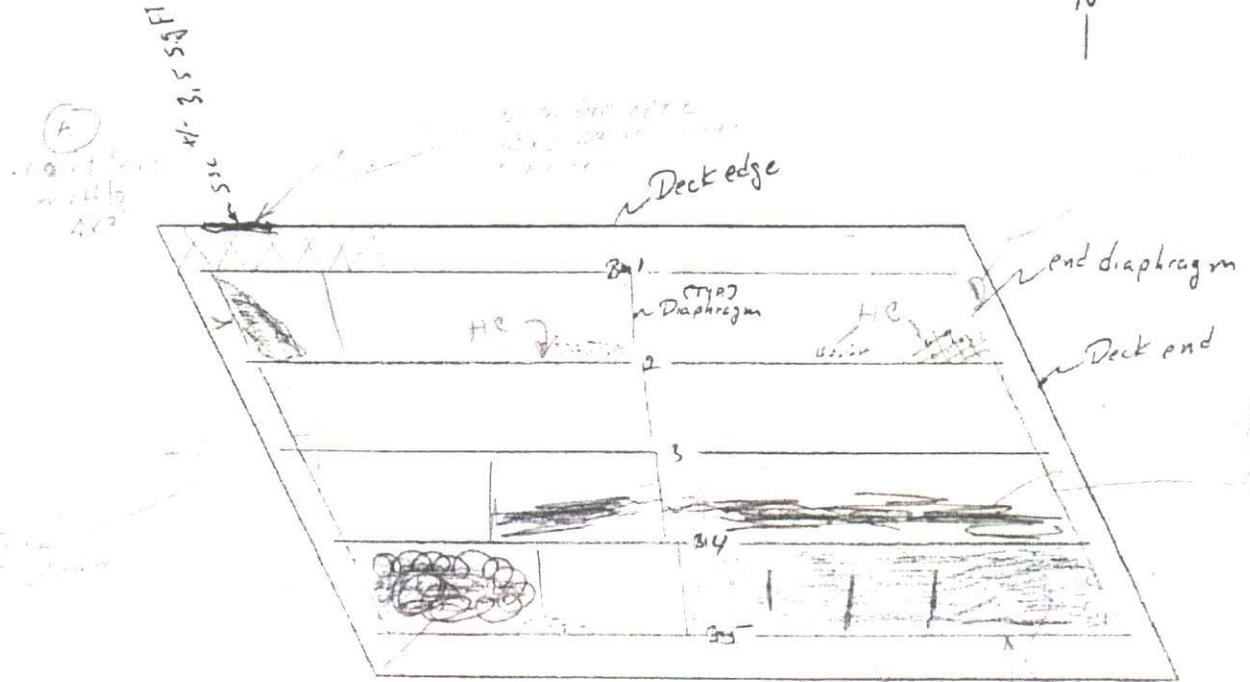
SUBJECT  
BR #4211 South Park Ave. - Mill River, Easton  
Framing Plan, Deck U.S. Side Condition  
"In-Depth"  
N.T.S. Scale

(A) = Shaded area = latent cracks, discolored, and flaking concrete with traces of efflorescence.  
 (B) = honey comb } = approx 15% of U.S. side.

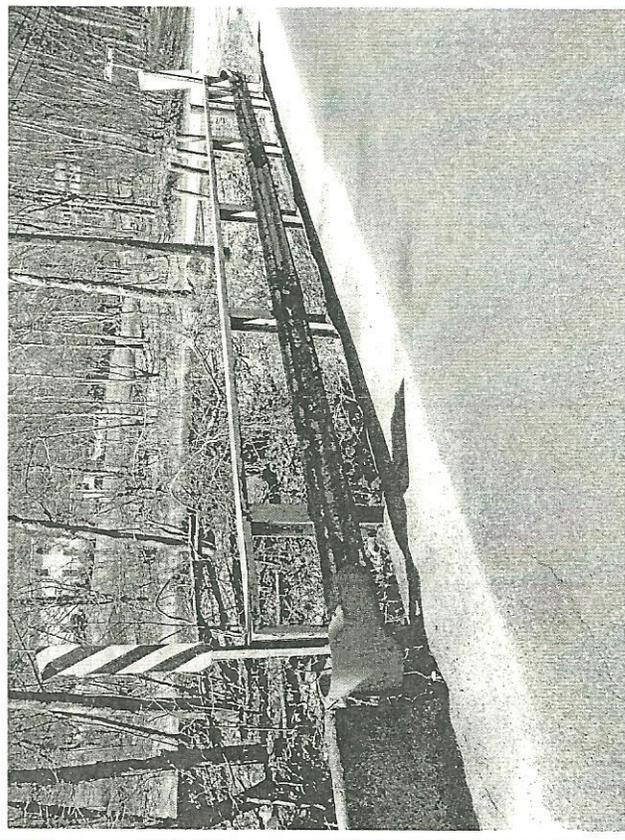
Rating	
<b>BRIDGE RAILINGS:</b>	Last Inspection: 0 Current: 0	SEE PHOTO # 3.
<b>TRANSITIONS:</b>	Last Inspection: 0 Current: 0	-
<b>APPROACH GUARDRAILS:</b>	Last Inspection: 0 Current: 0	-
<b>APPR. GUARDRAIL ENDS:</b>	Last Inspection: 0 Current: 0	-

Photo # 3: View of south railing.

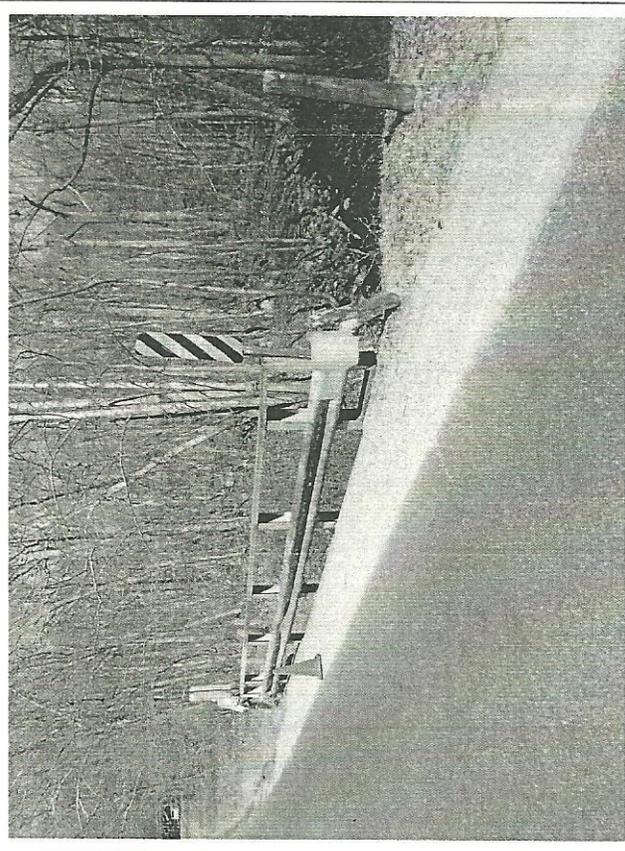
<b>APPROACH SLAB:</b>	N	-
<b>RELIEF JOINTS:</b>	N	-
<b>APPROACH GUIDE RAIL:</b>	N	NO APPROACH RAIL SYSTEM AT THE STRUCTURE.  SEE PHOTO #4.  THERE ARE SOME SINGLE TIMBER POSTS ALONG THE APPROACH SHOULDERS, WITH NO CABLES. TEMPORARY BARRIER AT THE SOUTHEAST. SEE PHOTOS # 1 & 2.
<b>APPROACH PAVEMENT:</b>	7	MACADAMIZED APPROACH ROADWAYS- RANDOM TRANSVERSE, LONGITUDINAL, AND RANDOM CRACKS, AREAS OF LIGHT TIRE WEAR. SEE PHOTO # 8. WEST END SHOWS A 6 FEET BY 6 FEET DEPRESSED BITUMINOUS PATCH. SEE PHOTO # 6.
<b>APPROACH EMBANKMENT:</b>	5	LIGHT EROSION, FROM ROADWAY RUN-OFF, IS NOTED BEHIND THE SOUTHEASTERLY WINGWALL.

Photo # 4: View of north railing.

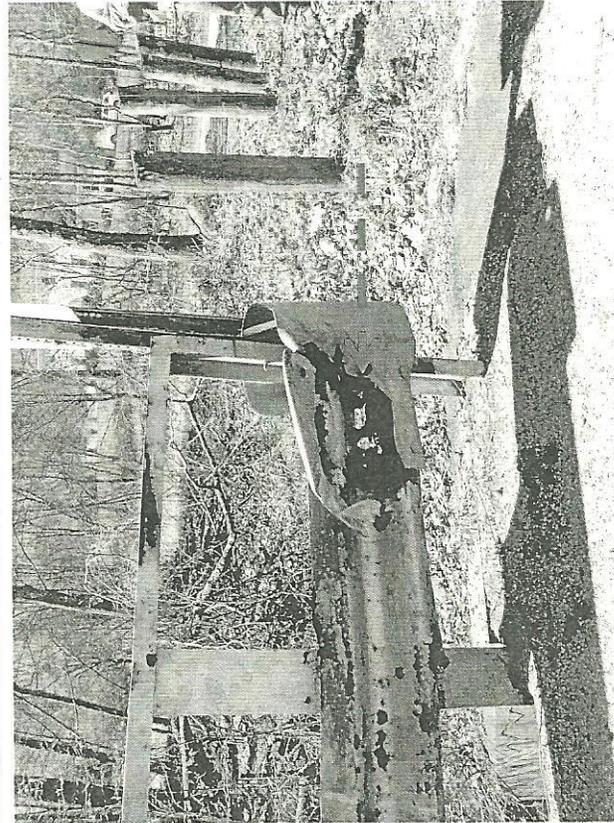
**Photo # 5: View of M.B.R at southwest corner exhibits collision damage with a large tear.**

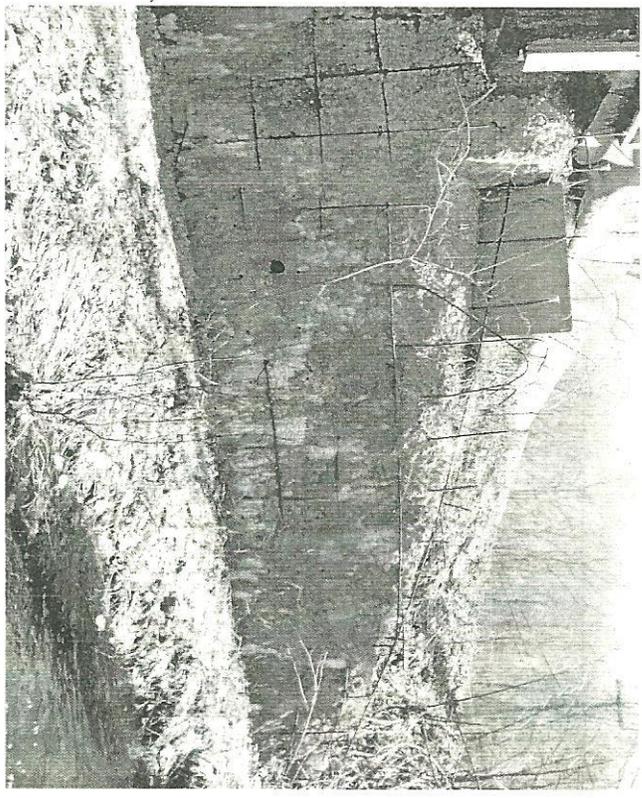
<b>ABUTMENTS- WINGWALLS:</b>	4	<p>THE SOUTHEASTERLY WINGWALL IS PAST NOTED AS BEING (**UNDER REPAIR**). IT IS HEAVILY DETERIORATED THRU OUT, AND IT ALSO APPEARS THAT SOME PAST DEMOLITION WORK MAY HAVE BEEN STARTED, BUT HAS NOT CONTINUED ANY FARTHER, AT THIS POINT IN TIME. 119 SQ.FT. OF DETERIORATION. THERE IS A HAZARD OF REBAR STICKING OUT 33 INCHES FROM THE WINGWALL. SEE PHOTO # 12.</p> <p>THE SOUTHWESTERLY WING SHOWS ABOUT 6 SQUARE FEET OF SEVERE SCALING , 4 INCHES DEEP, ALONG THE FREE END OF THE WING, AND ABOUT 2 SQUARE FEET ALONG THE CAP, NEAR THE STRUCTURE. SEE PHOTO # 11.</p> <p>THE NORTHEASTERLY WING SHOWS APPROXIMATELY 75 SQUARE FEET MAP HAIRLINE CRACKS WITH EFFLORESCENCE, AREAS OF MEDIUM- HEAVY SCALE ALONG THE CAP. SEE PHOTO # 21</p> <p>TOP OF THE NORTHWEST WINGWALL SHOWS A SHALLOW SPALL ON THE CAP ADJACENT TO THE RAILBASE APPROXIMATELY 2 SQUARE FEET BY 3 INCHES DEEP.</p>
<b>PIERS/BENTS- CAPS:</b>	N	-

<p>**EROSION AND WINGWALL ARE STILL CONSIDERED UNDER REPAIR @ THIS TIME**. ALSO MINOR EROSION ALSO BEHIND SOUTHWEST WING. BACK OF THE SOUTHEAST WINGWALL IS EXPOSED 8 FEET LONG BY 2 FEET HIGH.</p>
--	---

Photo # 12: View of southeast wing.

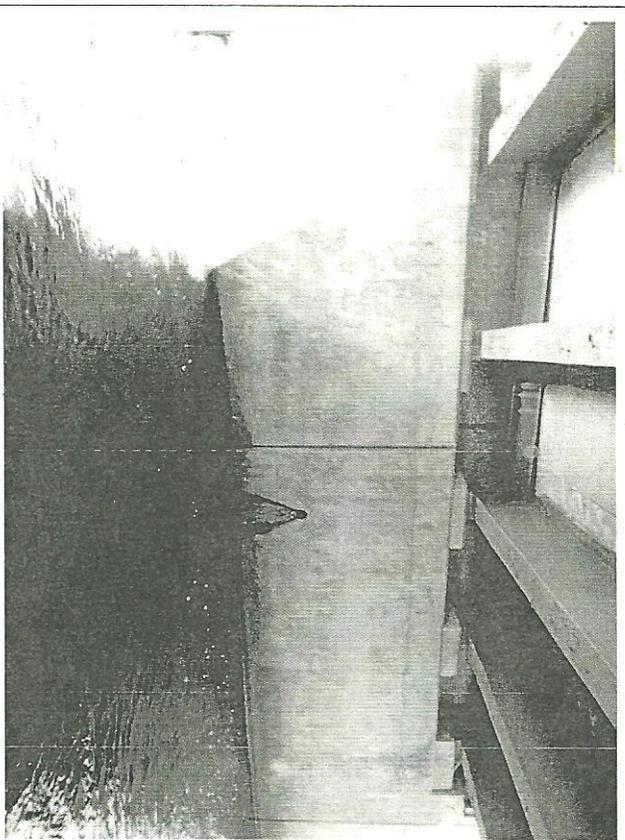
ABUTMENTS-FOOTINGS:	6	<p>THE SOUTH END OF THE WEST ABUTMENT FOOTING IS EXPOSED FOR APPROXIMATELY 20 LINEAR FEET.                  THE VERTICAL FACE IS EXPOSED APPROXIMATELY 2- 4 INCHES HIGH AT RANDOM LOCATIONS.</p>
ABUTMENTS-SETTLEMENT:	8	-

Photo # 13: View of west abutment.

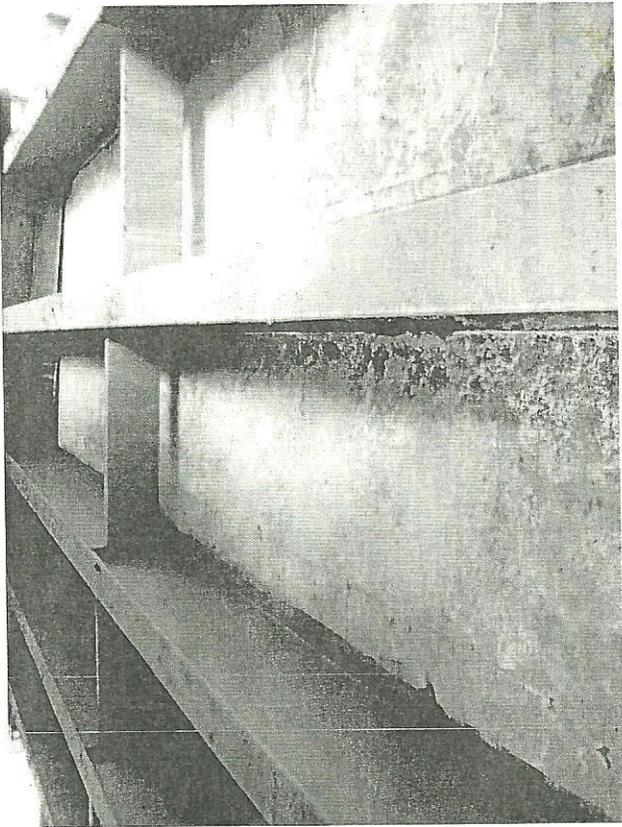
OVERLAY:	7	NEWER MACADAMIZED OVERLAY. NO KNOWN MEMBRANE. BITUMINOUS DOES NOT EXTEND TO DECK EDGE. (1) GOUGE IN THE OVERLAY 18 INCHES BY 1/4 INCH DEEP. SAND AT THE CURBLINES.
DECK-STR. CONDITION:	5	THE DECK U-SIDE SHOWS FORM PANEL LINES, SHRINKAGE WITH CURING CRACKING, LIGHT HONEYCOMBING, SHALLOW EXPOSED WIRES, LATENT CRACKING, DISCOLORATION, DAMPNESS, TRANSVERSE CRACKING WITH AND WITHOUT EFFLORESCENCE, AND FLAKING CONCRETE. MAP HAIRLINE CRACKS WITH AND WITHOUT EFFLORESCENCE. THE MOST CONCENTRATED CONDITIONS ARE NOTED ALONG THE TWO SOUTHERLY SIDE BAYS.  THE SLAB EDGE ALONG THE NORTHWESTERLY CORNER, SHOWS ABOUT 6 SQUARE FEET OF SEVERE SCALING TO THE SLAB EDGE. (NOT VISIBLE DUE TO WOODEN FORMS IN PLACE)  THE TOTAL AREA OF CONTAMINATION WITH DETERIORATION IS ABOUT 20 PERCENT. <span style="margin-left: 40px;">P23</span> SEE PHOTO # 15.
CURBS:	N	-
MEDIAN:	N	-

Photo # 15: View of deck underside.

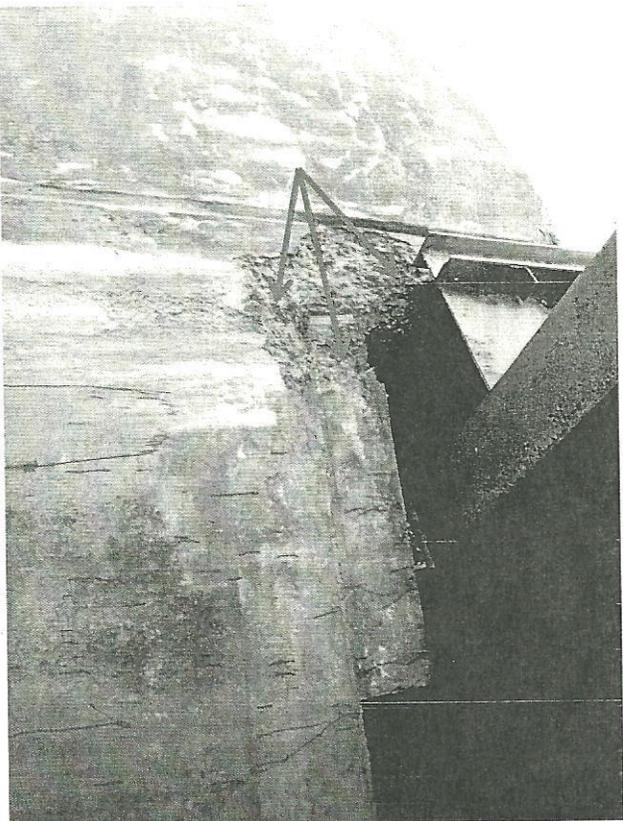
ABUTMENTS-STEM:	4	<p>BOTH ABUTMENTS ARE THE FULL HEIGHT, CONVENTIONAL SHAPED TYPE.                  BOTH SHOW FORM PANEL LINES, SHRINKAGE WITH CURING CRACKING, LIGHT HONEYCOMBING, SHALLOW WIRES, A LIGHT SCALE BAND ALONG THE BASE OF EACH, AND SOME PAST STAINING.</p> <p>THE SOUTHERLY END, OF THE EASTERLY ABUTMENT, SHOWS ABOUT 32 SQUARE FEET OF SEVERLY DETERIORATED, AND HOLLOW CONCRETE, WHICH CONTINUES INTO THE WINGWALL UP TO 8 INCHES DEEP.                  SEE PHOTO # 17.</p> <p>THE BEARING DEVICE IN THIS AREA IS THREATENED.                  SEE PHOTO # 18.</p> <p>THE NORTHERLY CHEEKWALL OF THE SAME ABUTMENT SHOWS ABOUT 6 SQUARE FEET OF SEVERE SCALING, TO VARIOUS PORTIONS OF THE CHEEKWALL.                  SEE PHOTO # 16.</p> <p>THE WESTERLY ABUTMENT SHOWS A 1 SQUARE FOOT SPALL, OF THE CONSTRUCTION JOINT, ADJACENT TO THE WATERLINE.</p>
ABUTMENTS-BACKWALL:	7	<p>THE BACKWALLS SHOW FORM PANEL LINES, SHRINKAGE WITH CURING CRACKING, LIGHT HONEYCOMBING, SOME LIGHT SCALING, STAINS FROM PAST LEAKAGE, AND LATENT CRACKING.</p>

Photo # 16: View of cheek wall, bearing pedestal & abutment, exhibits severe scaling at northeast corner of east abutment.

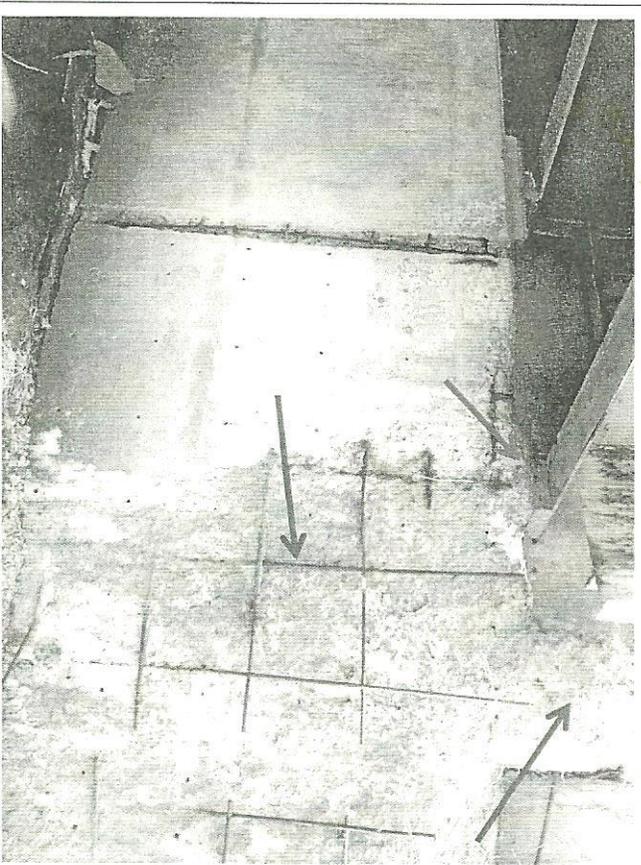
Photo # 17: View of cheek wall, bearing pedestal -5 & abutment, exhibits chip out concrete & severe scaling at southeast corner of east abutment.

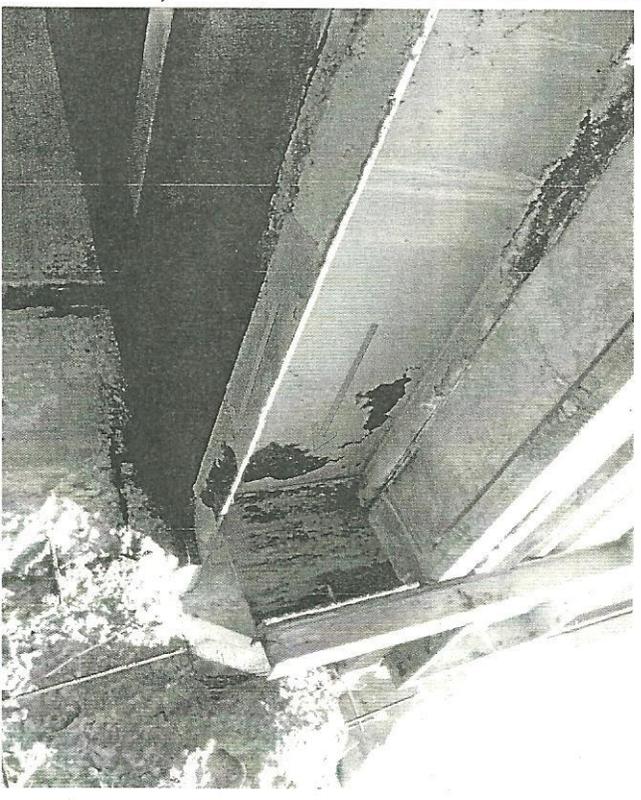
Photo # 18: View of laminar rust at web & flange, fascia beam-5 south side.

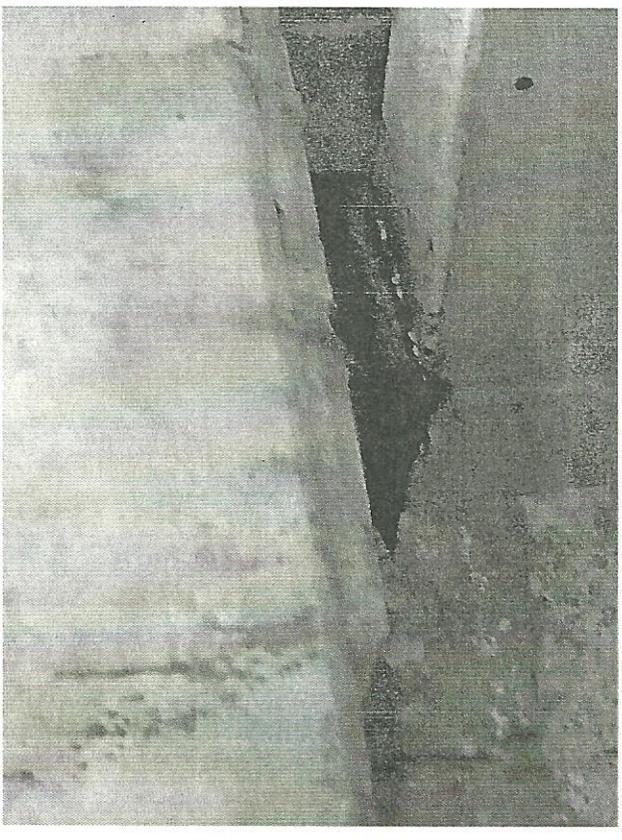
Photo # 20: View of heavy rust bearing-5 west abutment.
