Confidential Inspection Report

22 South Park Avenue
Easton, CT 06612

July 20, 2022

Robert Camarda
Cornerstone Home Inspection

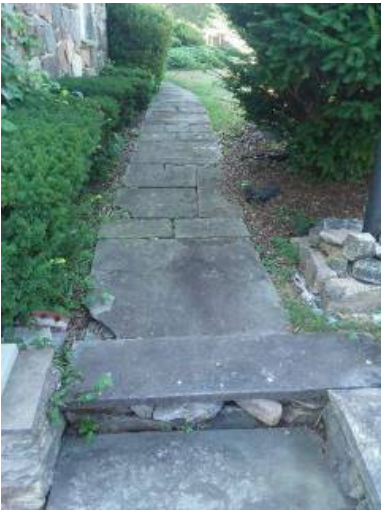
The walks are made of flagstone. Common cracks were observed. Repair as needed. There is some wear noted at the sidewalk or material. Some attention is suggested.

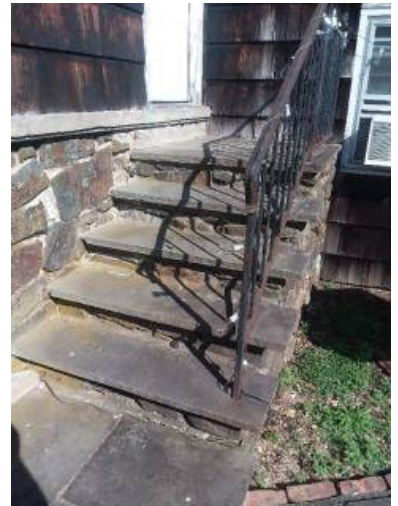
Stairs at the rear are made of flagstone and stone. Some deterioration was observed, and attention will be needed. The riser heights or tread depths are irregular, and there is a greater risk of tripping with less uniformity, and especially with unconventionally high steps. Loose steps were found. The hand rail is deteriorated. It should be repaired or replaced. The handrail is loose. We recommend improvement. The guardrail is too low. We recommend improvement for safety. Flashing is not visible between the steps/stoop and the siding. Flashing is used to prevent water seepage from infiltrating the siding at this joint. Monitor for now and repair as needed. Calcification was observed. This occurs when water gets into the masonry, dissolves minerals in the mortar or masonry, and then seeps out. This is to be expected with most exterior masonry stairways, patios, etc. We recommend that you consult with a competent mason to determine a solution to minimize this in the future.

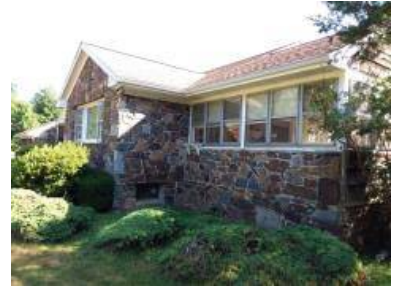
The walls are covered with wood siding and masonry.

Much of the siding is worn and damaged.

We recommend replacing the siding and much of the trim. The masonry and mortar need to be touched up.

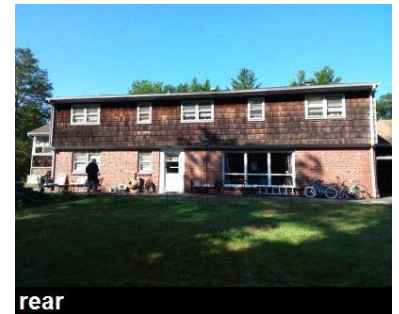
rear

The siding has been left to weather naturally and it has developed fungus-like discoloration throughout. This can be cleaned off for now but it doesn't have any protective coating. To minimize staining and deterioration and to maximize its longevity, the siding should be waterproofed, stained or painted. Painting/staining and/or routine repairs are recommended.

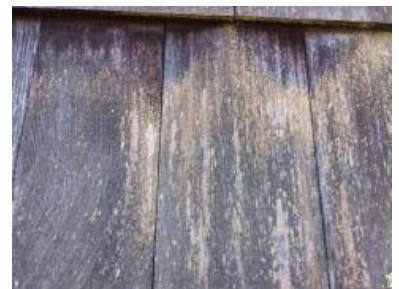
Some common cracks were found.

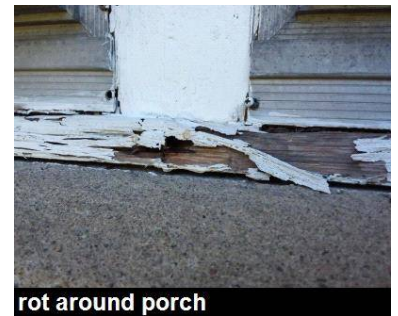
rot around porch

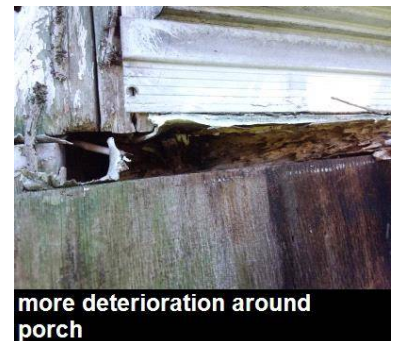
more deterioration around porch

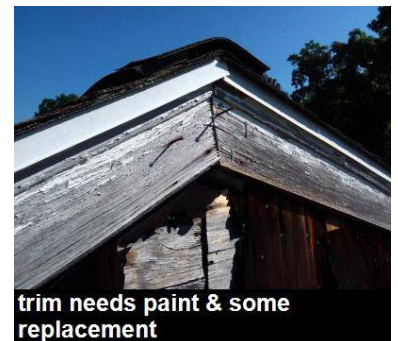
There is damaged or improper flashing over various trim pieces. This may allow water seepage into that area and can lead to damage.

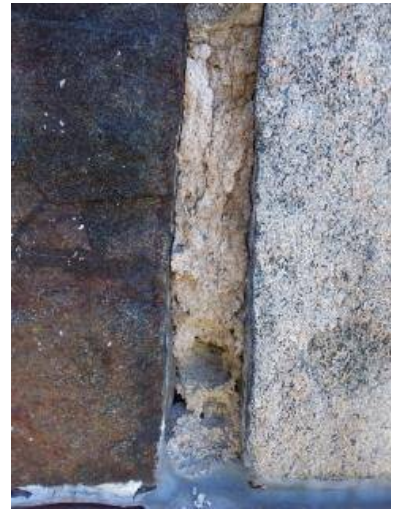
- ☐ ☒ ☐ Some of the mortar between the bricks is deteriorated. We recommend repairing to prevent water intrusion and further deterioration to the chimney.

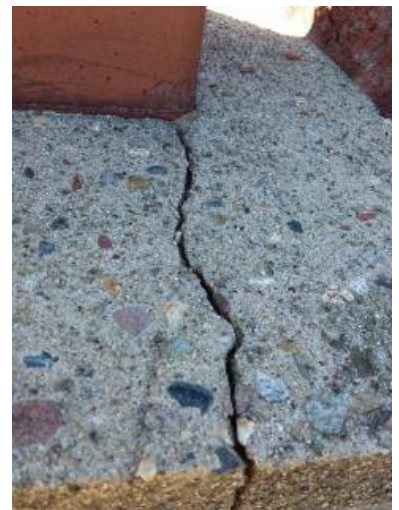
The crown is in satisfactory condition with minor cracks. Some attention is needed.

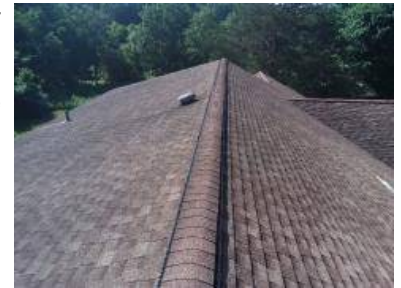
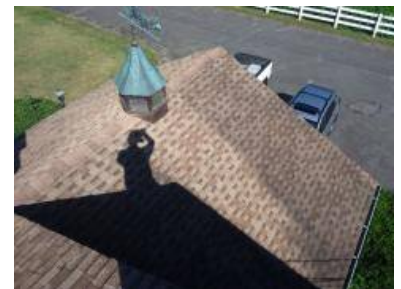
The roof is covered with one layer of asphalt composition shingles (fiberglass mats impregnated with asphalt). The roof appears to be beyond mid-life. The roofing material appears older, worn and weathered. It is dry and has lost much of its flexibility. It is still serviceable at the moment but should be monitored closely and you should budget for replacement over time.

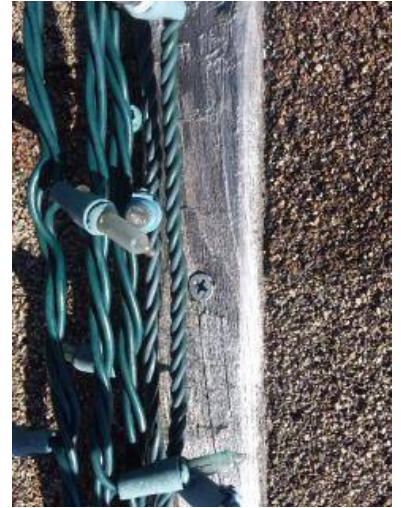
More exposed fasteners were found at the lights that are fastened with screws to the roof.

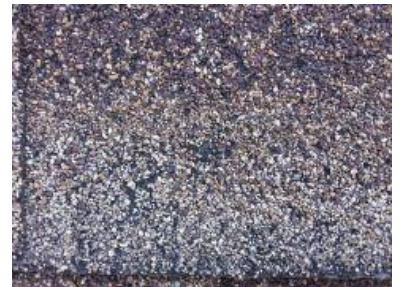
Particle loss is to the point that the material looks pitted.

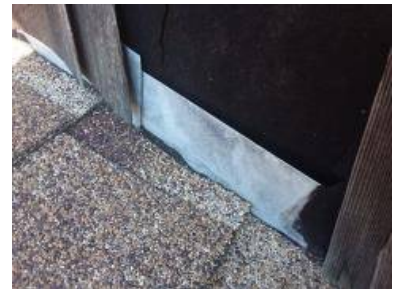
- OK MM RR
☐ ☒ ☐ Exposed step flashing will eventually leak. Siding should be reinstalled to properly cover the flashing.

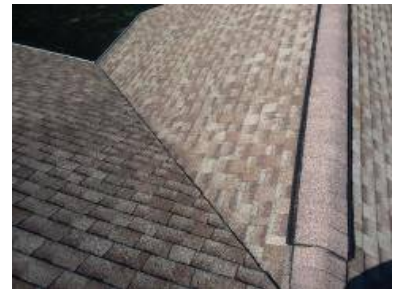
- ☒ ☐ ☐ The valleys appear to be in satisfactory condition.

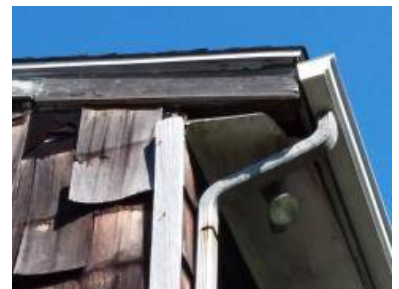
- ☐ ☒ ☐ There is some deterioration in many of the soffits - this one is at the rear of the house over the patio. Repairs are suggested, and monitor gutters for overflowing to prevent ongoing deterioration.

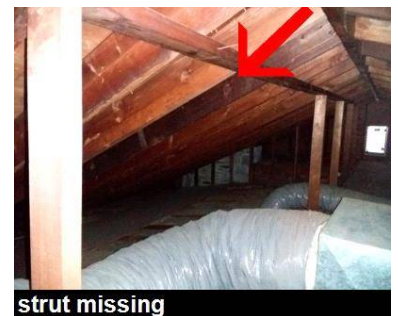
A strut support was removed from beneath the purlin to accommodate ductwork. We recommend further evaluation by a competent contractor.

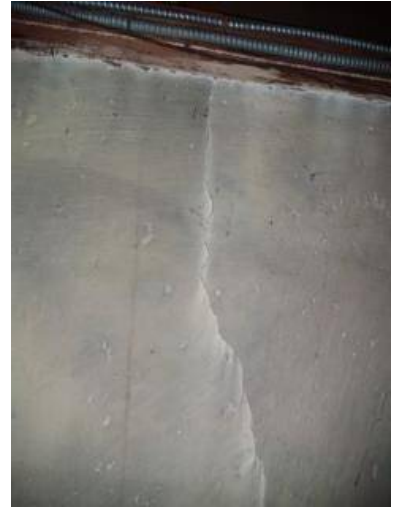
- ☐ ☒ ☐ Common cracking was found. We recommend sealing the cracks to prevent moisture intrusion, documenting them with photographs, and monitoring them over time. If movement continues and the cracks widen to a great degree (3/8" or more), then we recommend further evaluation and repairs by a qualified contractor.

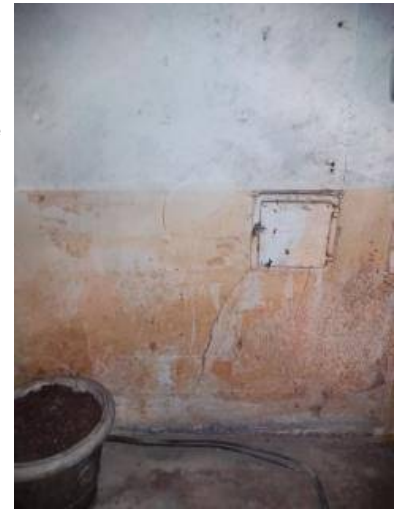
A waterline about 35" off the floor was observed around the entire basement. Stains of only a slight amount of water were also found. If this flooding occurred from outside water then what remedies have they implemented to prevent future occurrences? If the problem has not been adequately addressed then it seems almost certain that the area will flood again.

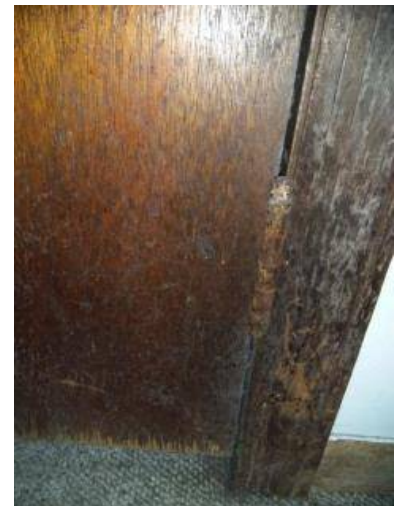
A mold-like patina was noticed on the lower part of the door in the basement.

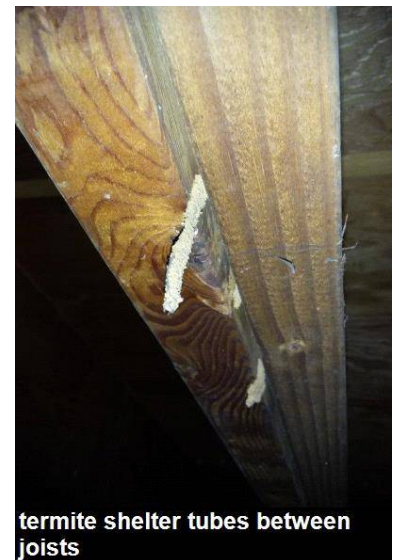
There is evidence of and damage from termites in several places in the basement. Some dead swarmers were also observed. We recommend further evaluation by a qualified contractor to repair, reinforce or replace any damaged wood, and that you consult with a qualified exterminator.

termite shelter tubes between joists

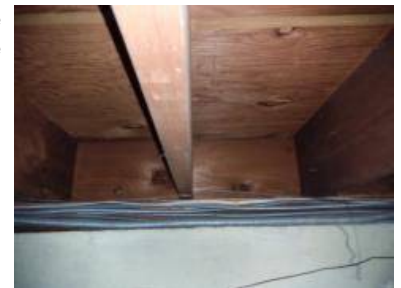
There is no insulation or vapor barrier in the basement ceiling. Consider adding it to improve comfort, to protect against moisture permeation, and for HVAC efficiency to the first floor.

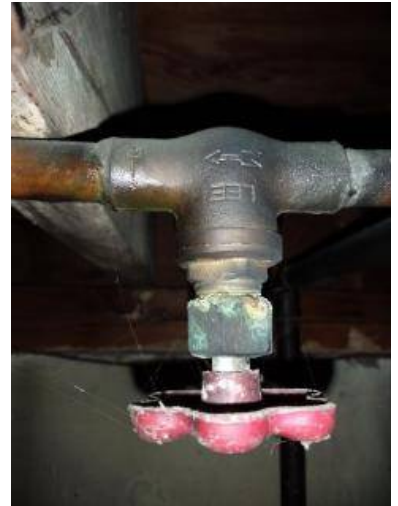
☐ ☒ ☐ Some corrosion was observed on valves and fittings. No active leakage was found, budget to replace parts, and continue to monitor. Some of the valves are older and/or corroded and should be replaced when you have the opportunity.

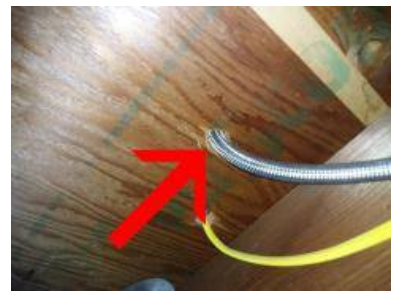
An appliance water supply pipe is not a permanent pipe type and is not permitted to run through walls or floors (pictured). We recommend replacement by a competent plumber.

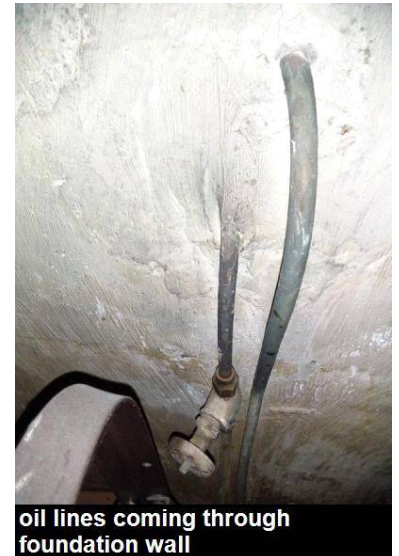
Another buried fuel tank might be on the property as they sometimes are with farms.

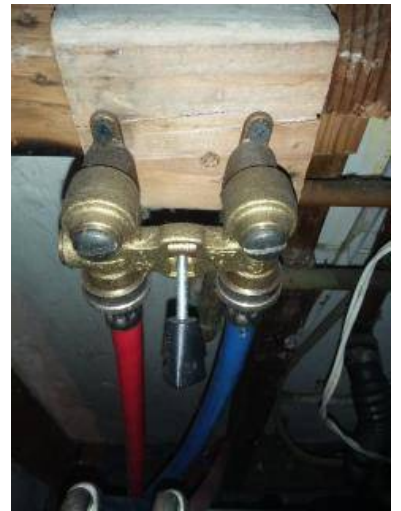
The visible parts of the plumbing appear serviceable. We recommend upgrading the washer supply hoses to heavy duty or a reinforced type.

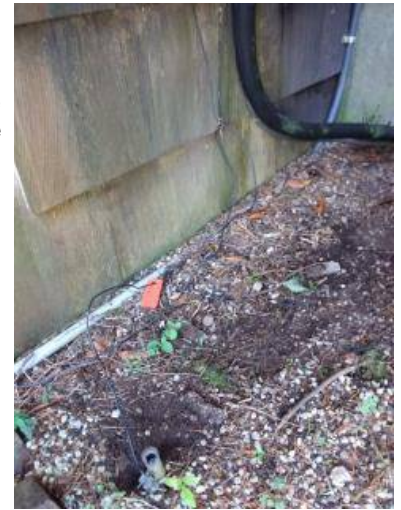
The purpose of a ground rod is to assist with dissipating static discharge voltage to earth, such as lighting. Ground rods were not located. Grounding rods should be buried and so they are not usually visible. Further evaluation would be needed to determine their existence, location and condition.

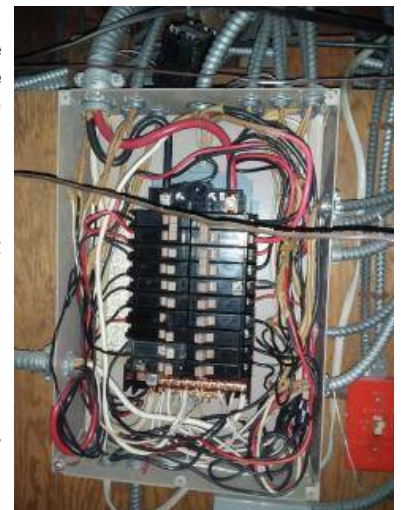
Unconnected wires inside the panel should be capped with wire nuts to protect them from accidentally becoming energized.

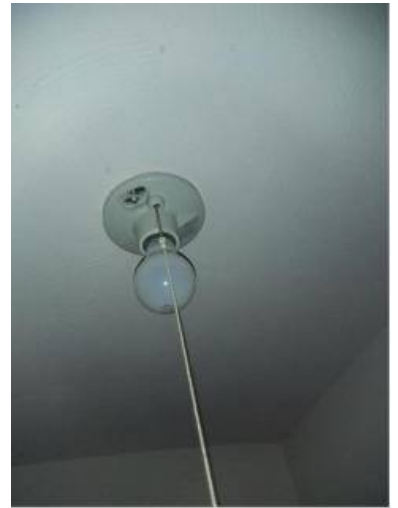
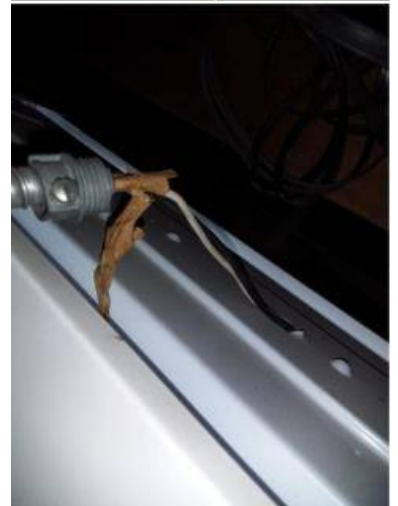
- ☐ ☒ ☐ Older-style fixtures in closets that can use incandescent bulbs can get hot and or overheat. We recommend replacing the fixtures with closet-rated fixtures. Some fixture(s) are improperly wired or otherwise need attention (lower picture). This one's in the basement.

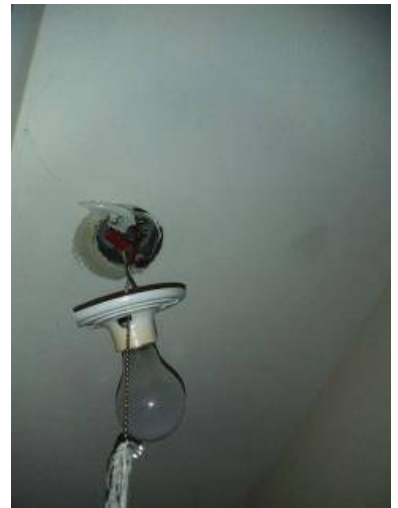
- OK MM RR
☐ ☒ ☐ Some fixture(s) are broken, improperly wired or otherwise need attention.

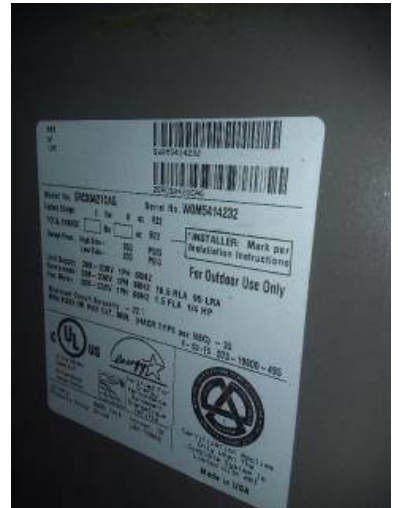
This condenser is 17 years old with a typical life of about 20 years. Regular maintenance is advised. The system uses R-22 refrigerant and that has been phased out by the US government because of damage that it causes to the ozone. Having limited access to this refrigerant could make future repairs more costly. And although there may be compatible alternative refrigerants available, we suggest you speak with your HVAC specialist or budget to replace it. The unit was tested or was already running and it produced adequately cooled air.

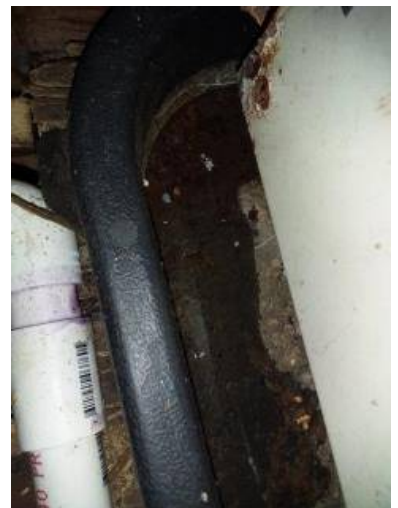
Water is found in the catch pan indicating a leak in the primary drain pan or system. Since this pan's purpose is a safeguard, the system should be evaluated by a technician and the source of the leak corrected. There's no water-sensing switch in the secondary pan but there is a drain that should handle any overflow from the primary drain. Monitor the drain or the pan for water from time to time.

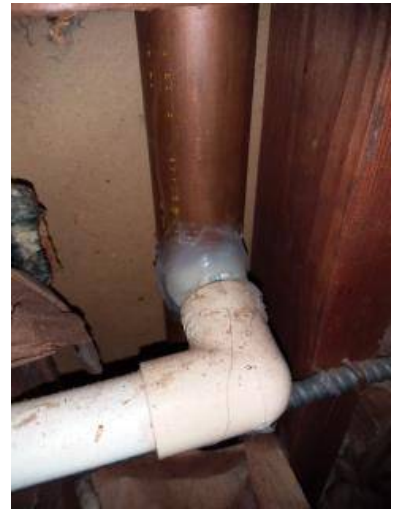
- ☐ ☒ ☐ Condensate line terminates at a poor location. The condensate line is running into a DWV pipe, which is part of the waste system, and this is improper. It is possible for gasses, odors, or bacteria from the sewage system to backup through the pipe and into the HVAC system or into the home. We recommend further evaluation by a competent plumber and HVAC specialist.

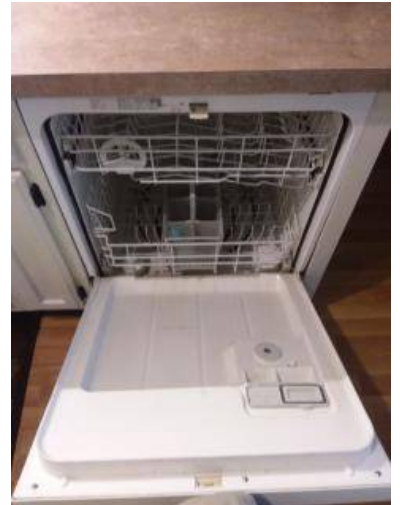
- OK MM RR
☐ ☒ ☐ The dishwasher was run through a cycle and appears to work properly. This appliance is older and near the end of its useful life. Budget to replace it.

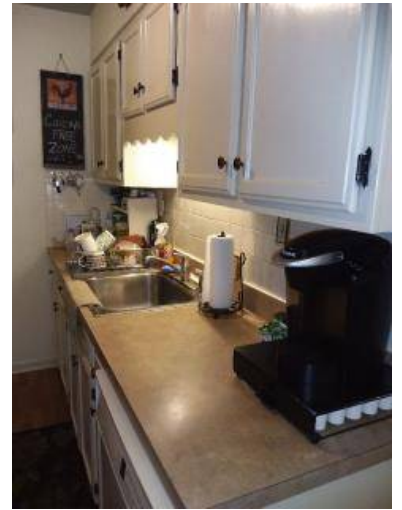
- ☐ ☒ ☐ The counter tops are formica (plastic laminate). There is minor wear noted and some attention may be needed.

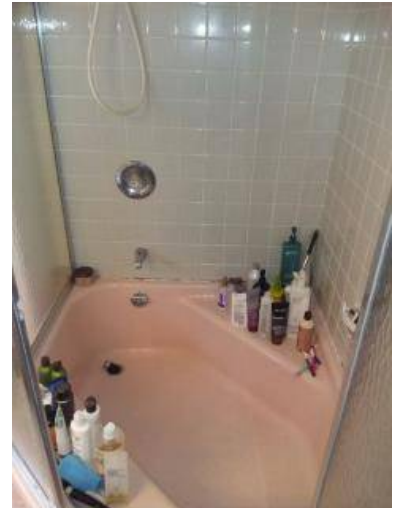
There is leaking at the shower diverter. Some repairs are needed. The showerhead is working as it should. The drain stopper mechanism is not operational.

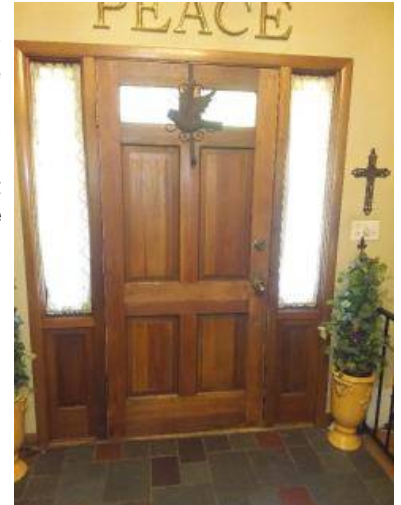
The main entry door is made of wood. The paint is peeling or chipping. The door should be prepped and painted. The door and hardware are operational. The weather stripping is serviceable. The glass in the door does not appear to be tempered. We recommend replacing it for safety. The doorbell does not work.

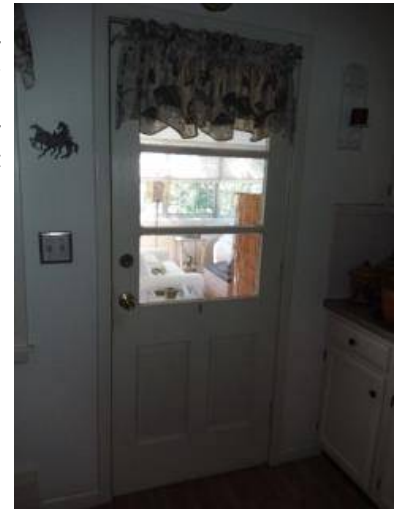
- ☐ ☒ ☐ The types of other exterior doors include standard side or rear door(s). The glass in the door does not appear to be tempered. We recommend replacing it for safety. Door has a keyed deadbolt on the interior side that could prevent egress in an emergency. We recommend replacing this with a hand-operated deadbolt.

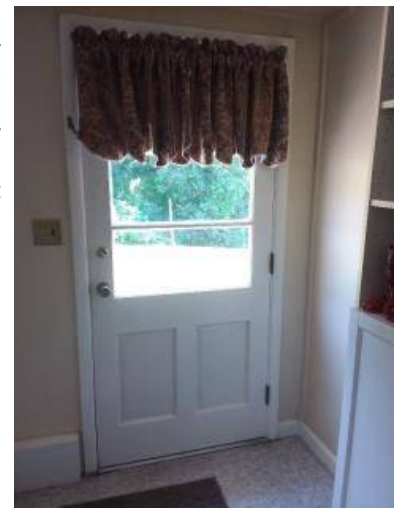
- ☐ ☒ ☐ The types of other exterior doors include standard side or rear door(s). The glass in the door does not appear to be tempered. We recommend replacing it for safety. Some doors have a keyed deadbolt on the interior side that could prevent egress in an emergency. We recommend replacing these with a hand-operated deadbolt.

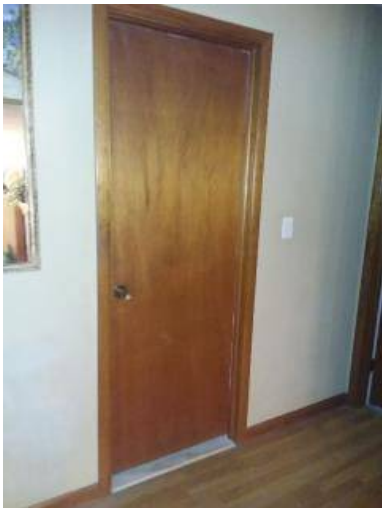
Overall, most doors are serviceable and hardware operational. Some doors rub, stick or won't latch. Some adjustments are needed.

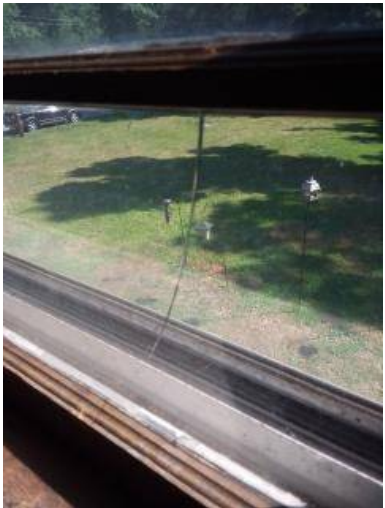
☐ ☒ ☐ One or more of the window panes is cracked.

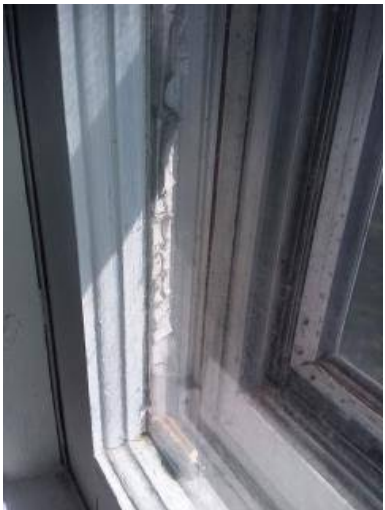
The window or associated hardware needs repair. Some portion of the glazing needs repair or replacement.

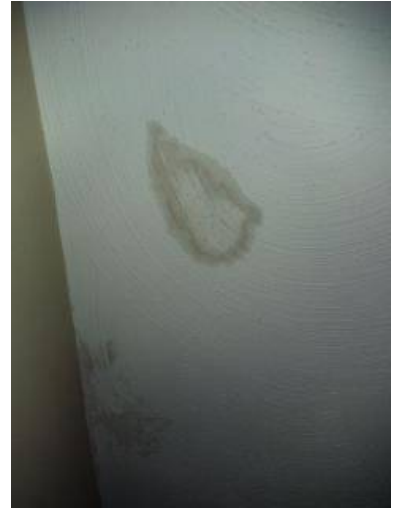
Moisture stains are noted throughout the ceiling on the 2nd floor and living room. The stains are dry at the time of the inspection. Monitor and take action if changes occur.

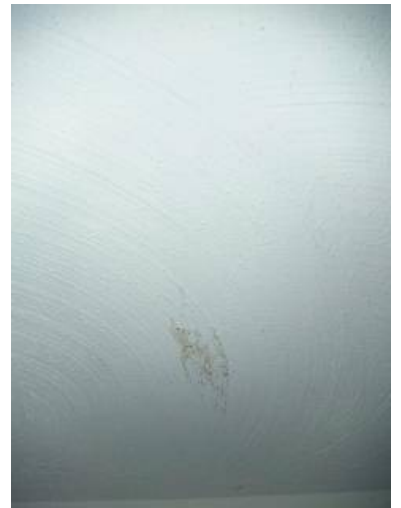
Moisture stains are noted in right 2nd floor rear bedroom closet ceiling. The stains are dry at the time of the inspection. Monitor and take action if changes occur.

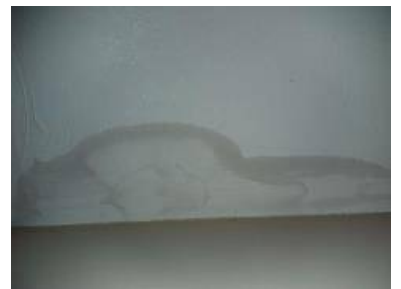
Moisture stains in the living room.

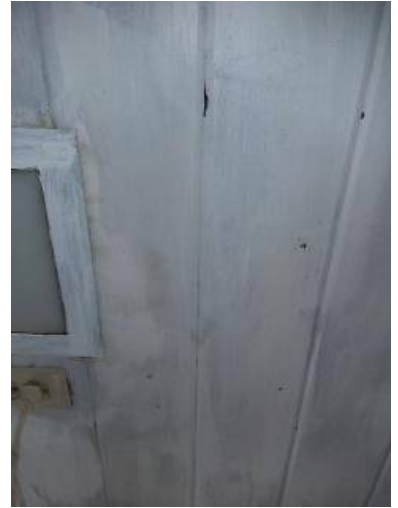
- ☐ ☒ ☐ Moisture stains are noted at porch ceiling. The stains are dry at the time of the inspection. Monitor and take action if changes occur.

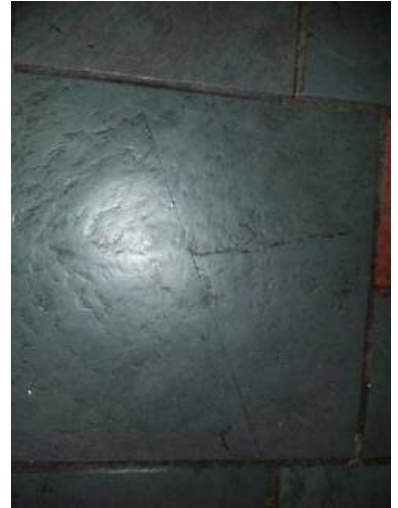
- OK MM RR
☐ ☒ ☐ Cracked tiles were observed in the entryway.

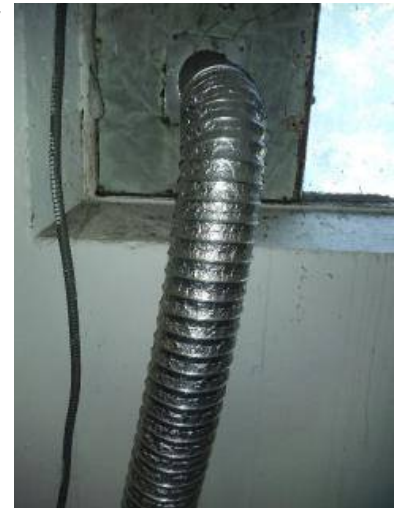
A dryer vent is provided but is not completely visible. Note that the vent pipe should be cleaned at least biannually. You should have the duct cleaned soon after you move in. We recommend upgrading the dryer exhaust duct to a smooth-walled metal pipe. This causes less resistance to the air flow, catches less lint, and is a lower risk for combustion.

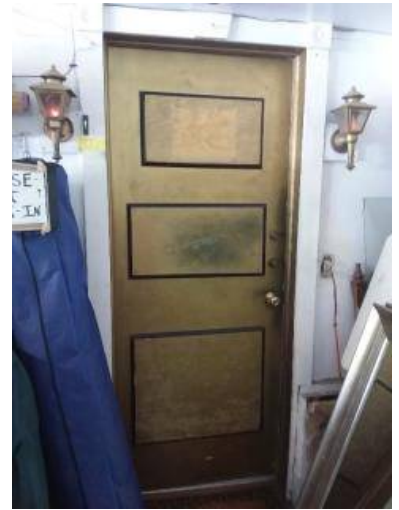
- ☐ ☒ ☐ The door to the living space is a fire-rated door. This door is keyed from the inside. We recommend improvements.
