Examples of Volunteer Restoration Work

Center Street Cemetery (c. 1860)

Cogswell Obelisk Restoration:

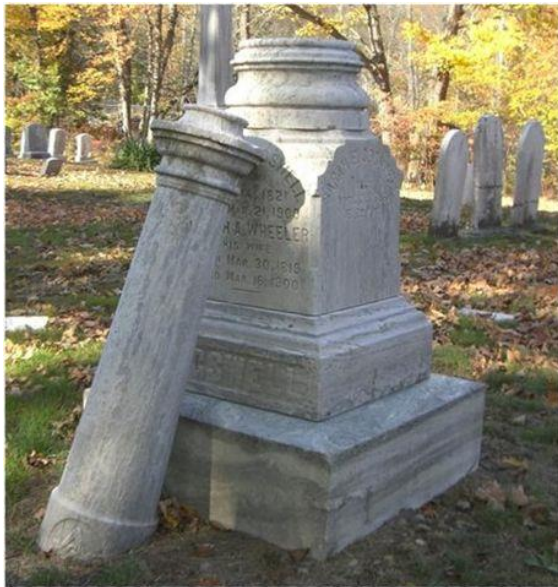
Cogswell Obelisk (Before)

This obelisk was found missing a steel rod necessary to stabilize and connect the piece leaning against the base of the monument. Volunteers used monument compound and epoxy to reset the obelisk shown pictured on the right.
