EASTON ROAD SAFETY AUDIT

MAY 21, 2021

Findings and Recommendations Report

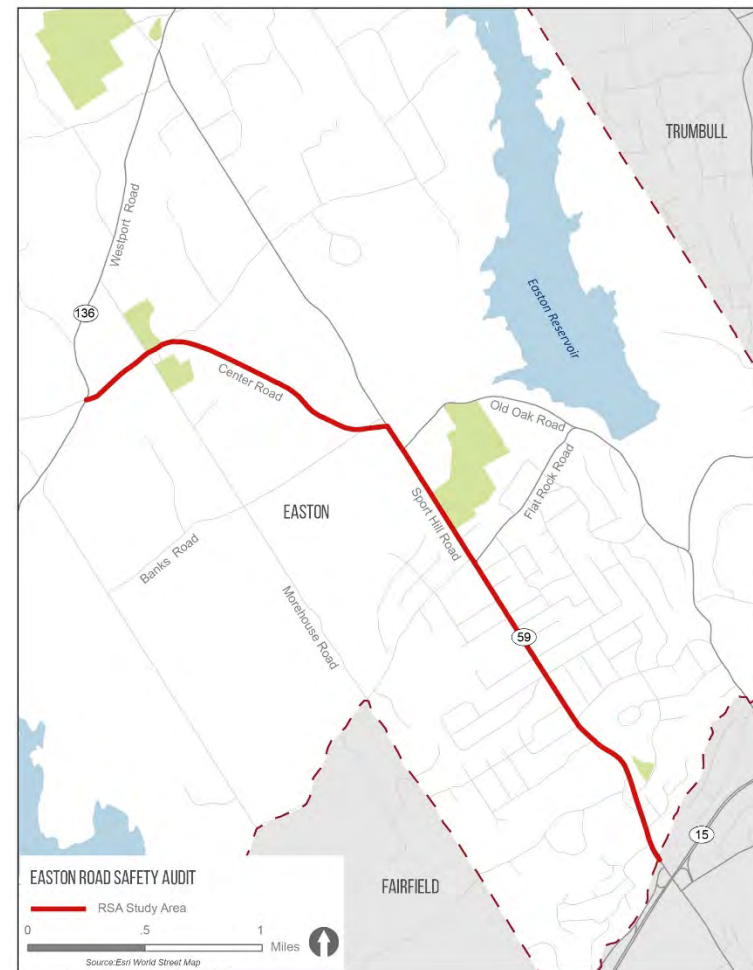
Figure 2: Easton RSA Study Area

CTDOT performed an RSA for the Town of Easton on Route 59 (Sport Hill Road) between the Easton/Fairfield town line and Center Road. The Study Area also extends along Center Road, between Route 59 and Route 136 (Westport Road). See Figure 2. The purpose of the RSA is to address any safety concerns while discussing possible safety improvements for pedestrians and bicyclists travelling along the study area corridor. The southern end of the study area, on Route 59, to Old Oak Road is in the Bridgeport-Stamford urbanized area.¹ The corridor serves many purposes including local and regional truck traffic, residential and business access, employment commuting, access to farms, Equestrian School, and access to the Merritt Parkway and points further south. See Figure 3.

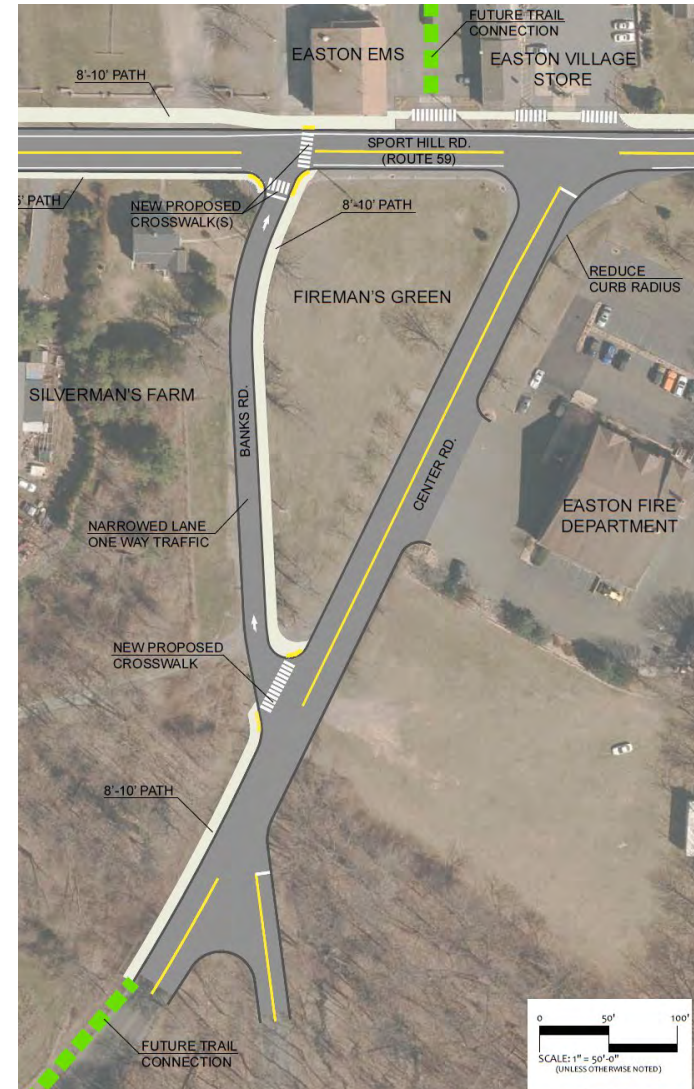
Figure 5: Charrette Concept Plan at Fireman’s Green

Prior Efforts in Study Area: In November 2019, a charrette was held that was focused on an area of Sport Hill Road, between the Hellen Keller School and Silverman’s Farm. Meetings were conducted with stakeholders, local agencies, and the public. The charrette led to the development of a series of concepts. These concepts included:

- 10-foot sidepath on the east side of Sport Hill Road
- Traffic island to calm traffic and serve as gateway near Silverman’s Farm and Hellen Keller School
- Crosswalks at Fireman’s Green
- Connections to Hellen Keller School

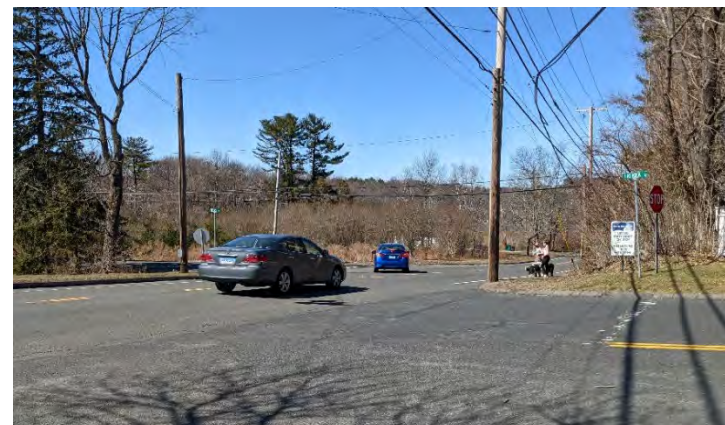
Figure 20: Intersection of Route 59 and Flat Rock Road

- Location of observed pedestrian crossings between Flat Rock Road and Beers Road
- Poor site lines south on Sport Hill Road because of hill
- Beginning of denser residential neighborhood area of Easton
- Poor sightlines looking north because of vegetation
- Intersection contains a flashing beacon

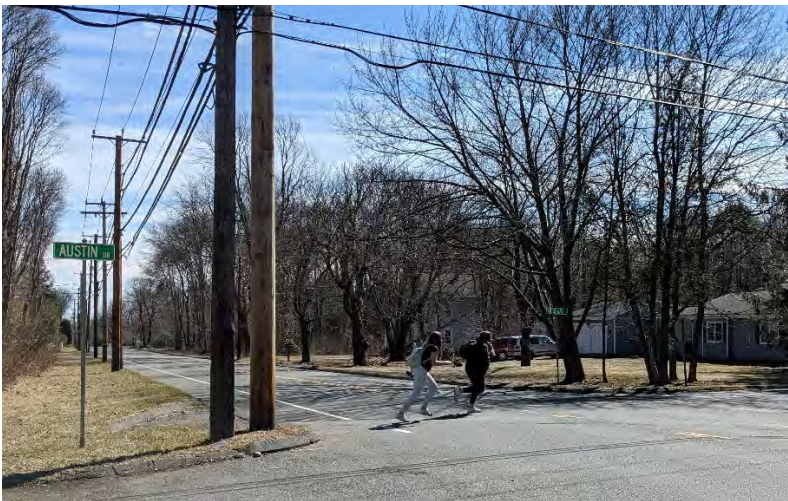
Figure 21: Pedestrians Crossing Route 59 at Austin Drive

- Pedestrian crossings observed at Austin drive and are known to cross at other locations
- Shoulders begin to widen
- Pedestrian traffic between neighborhoods east and west of Sport Hill Road

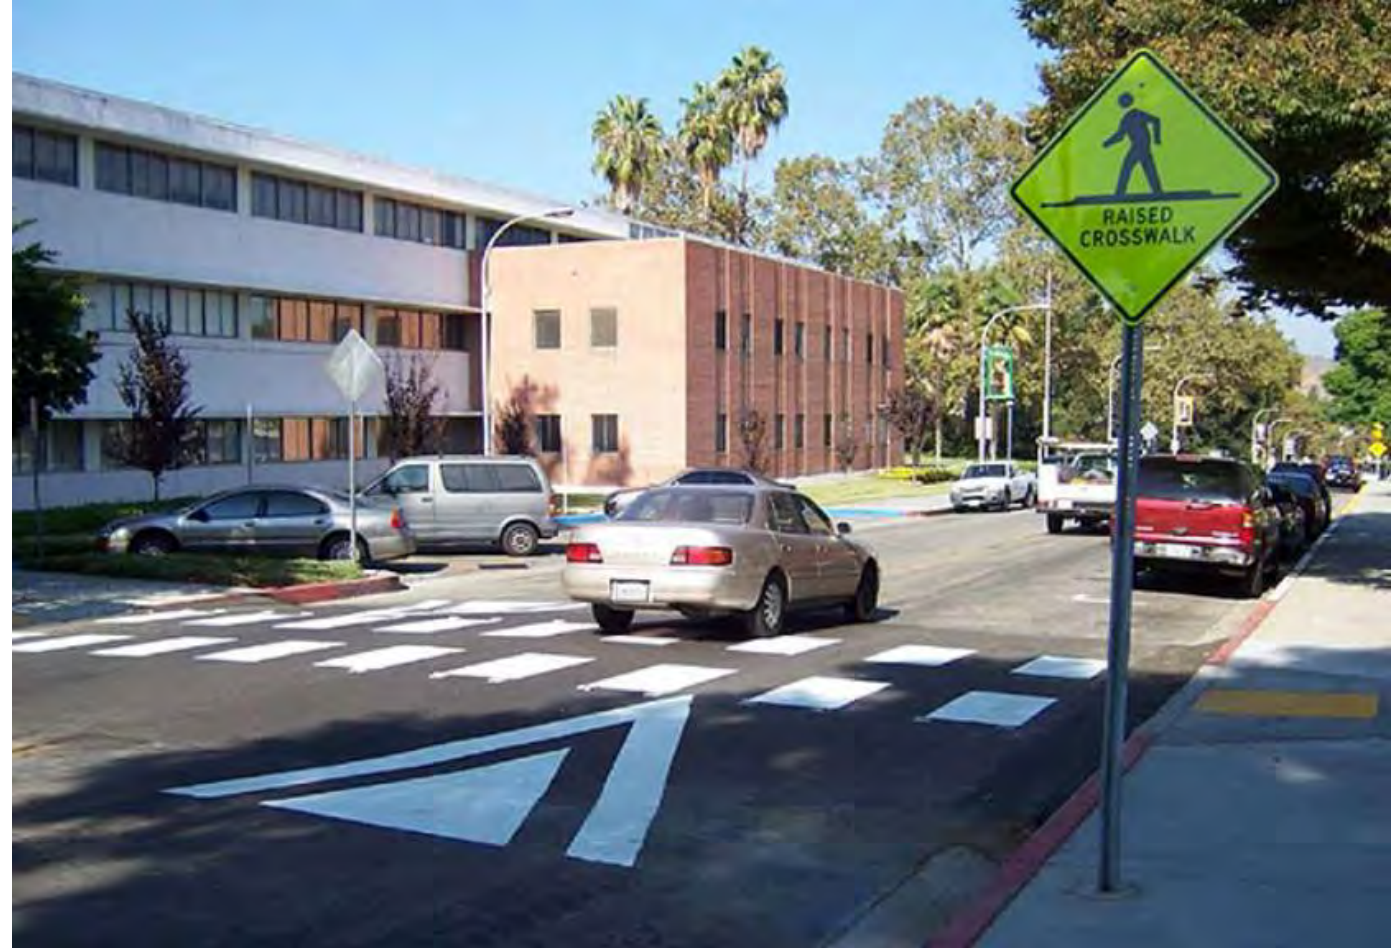
- Improves pedestrian safety by causing motorist speeds to decrease at the crossing.
- Typically between 3 and 6 inches above street level. It is common for a raised crosswalk to be level with the street curb.
 - Height increases the visibility of a pedestrian in a crosswalk to a motorist.

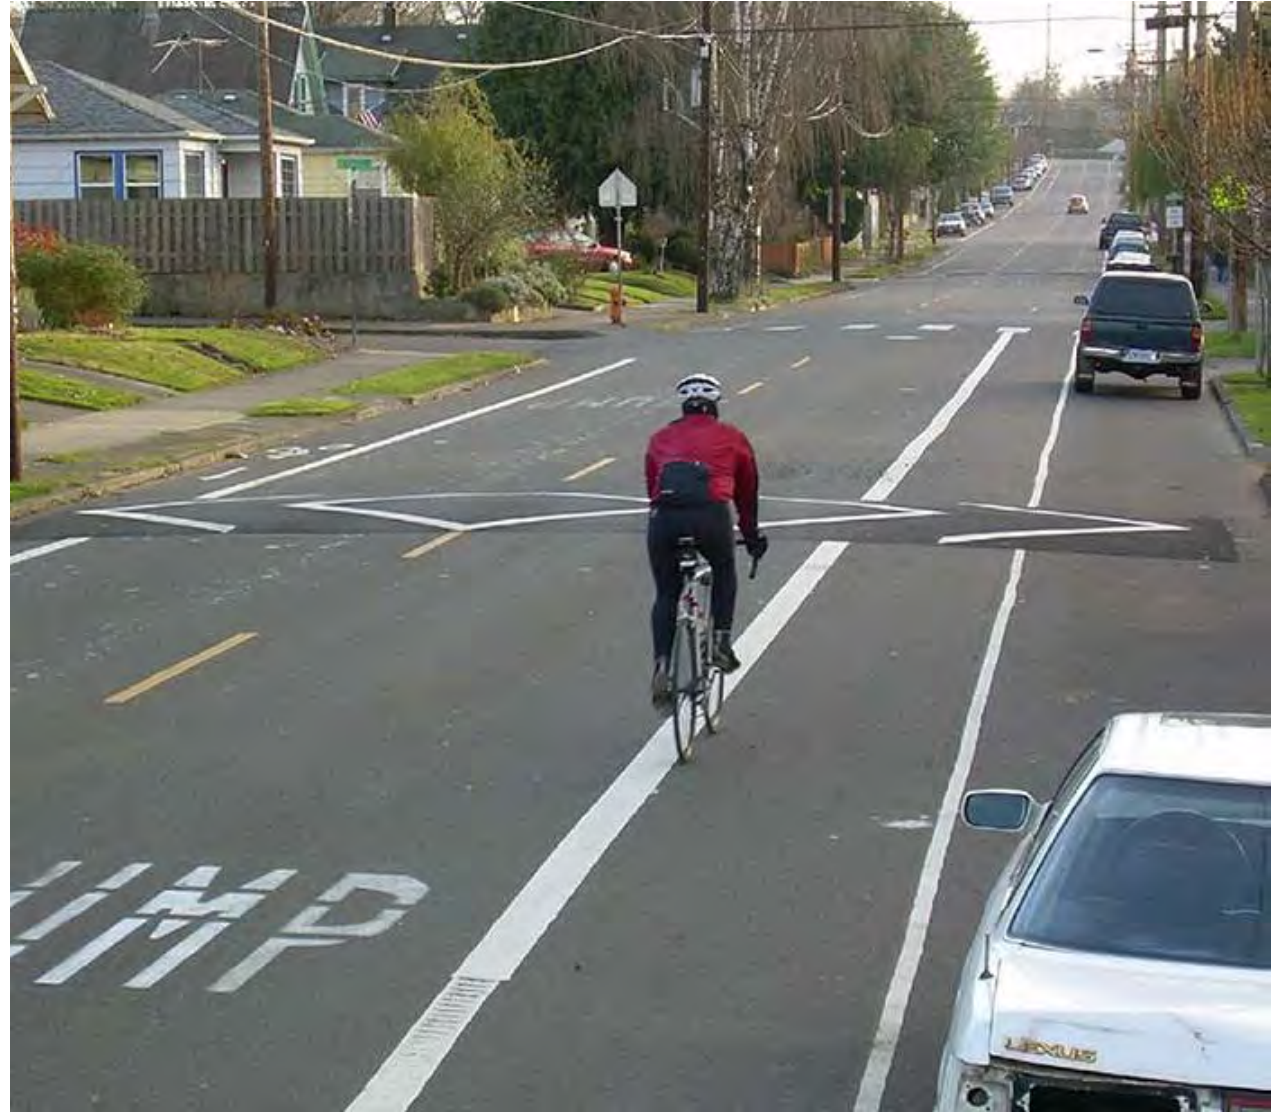
SPREED HUMP

- Typically 3 inches in height and 12 feet in length along the vehicle travel path axis.
- Encourages the motorist to travel at a slow speed.

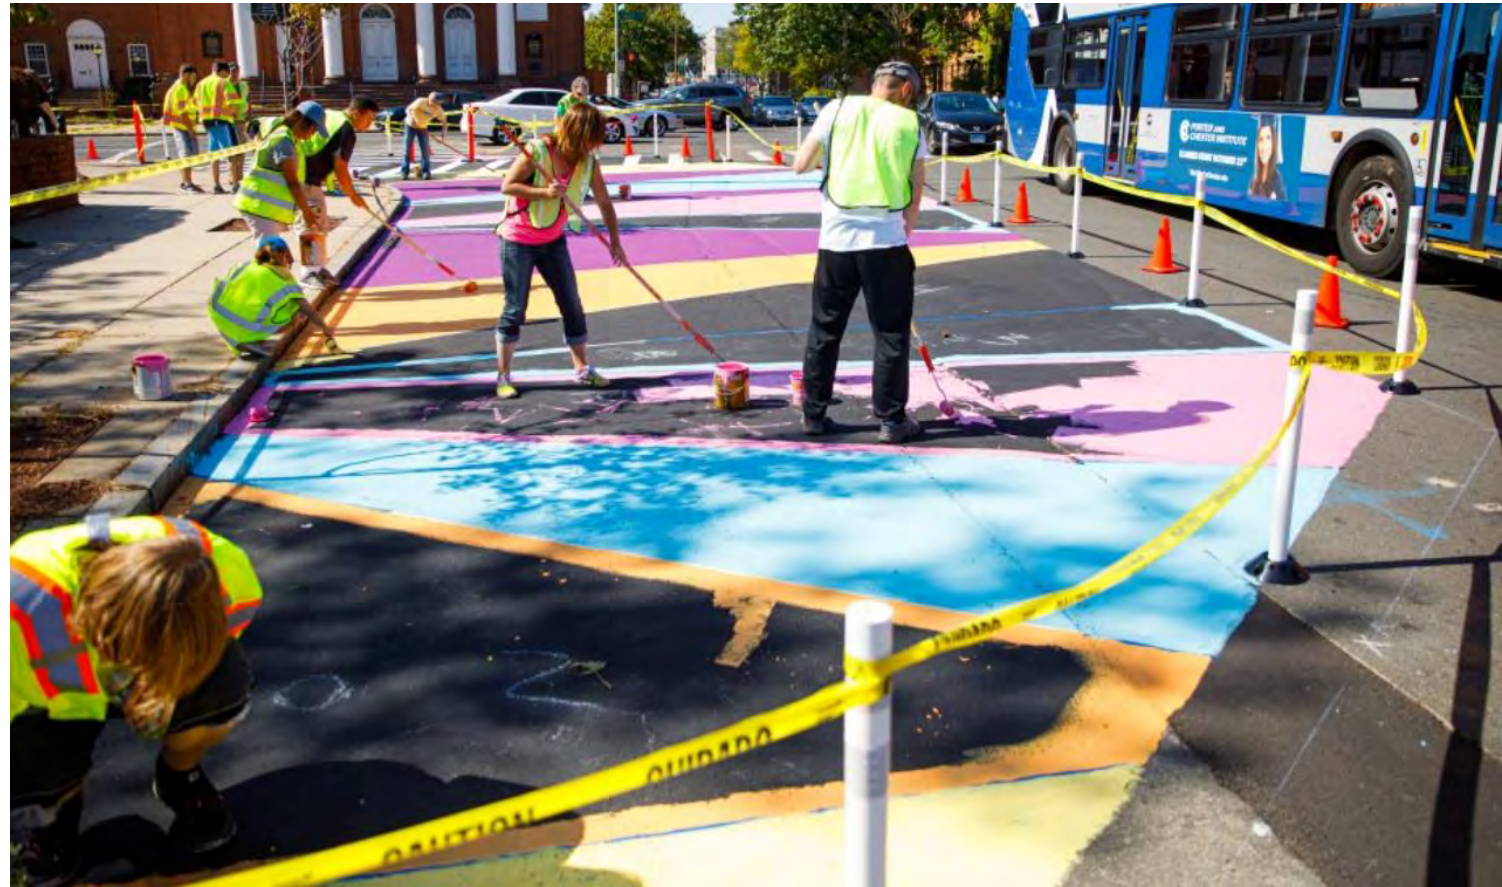
CORNER EXTENSION/BULBOUT

- A curb extension is a horizontal extension of the sidewalk into the street resulting in a narrower roadway.
- Slows automobile turning speeds, shortens pedestrian crossing distance, and increases pedestrian visibility

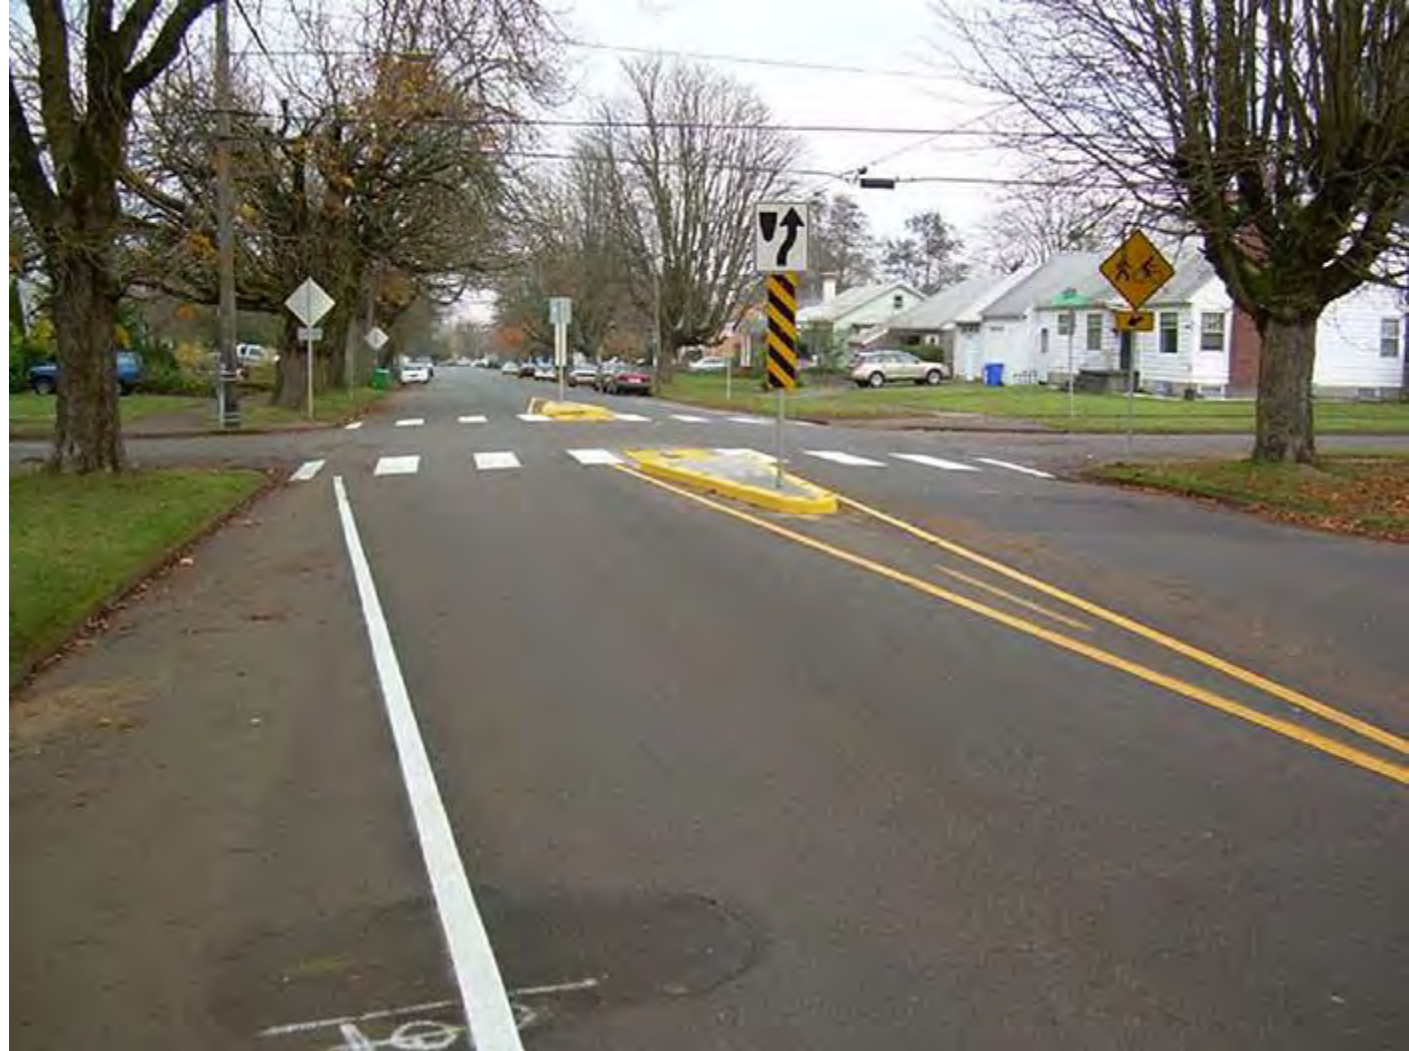
MEDIAN ISLAND

- Raised island located along a street centerline.
- Narrows the travel lanes at that location
 - Visual appearance of narrowed lanes encourages a motorist to slow.

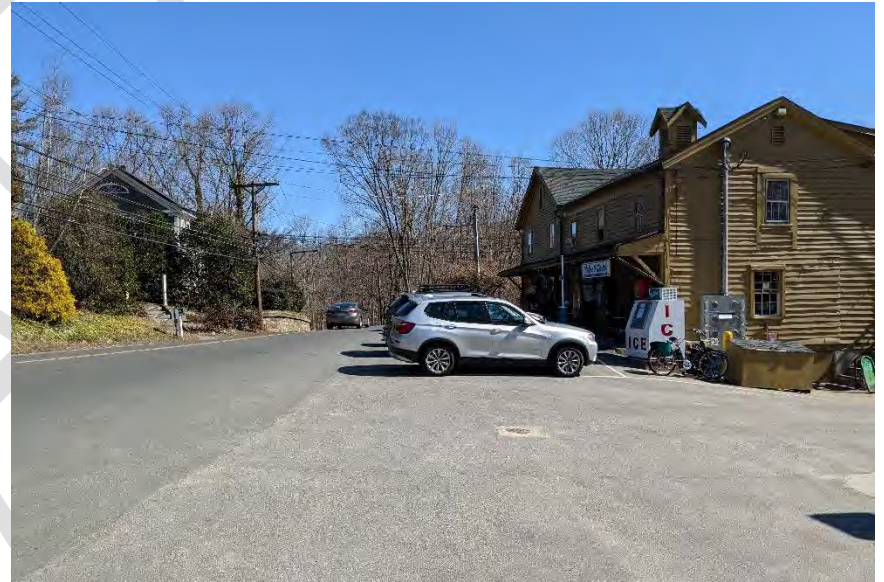
Figure 2: Parker area of Greiser's Coffee and Market, on Center Road

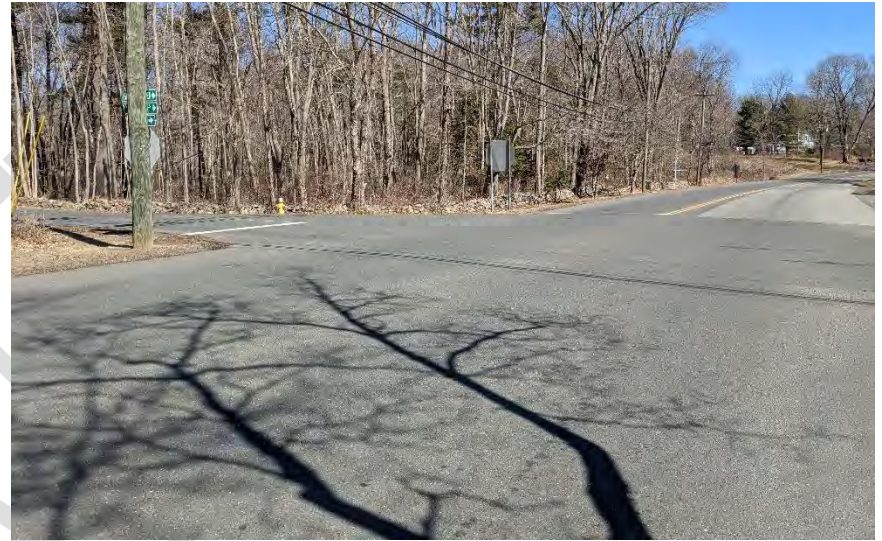
Figure 5: Intersection of Center Road and Morehouse Road

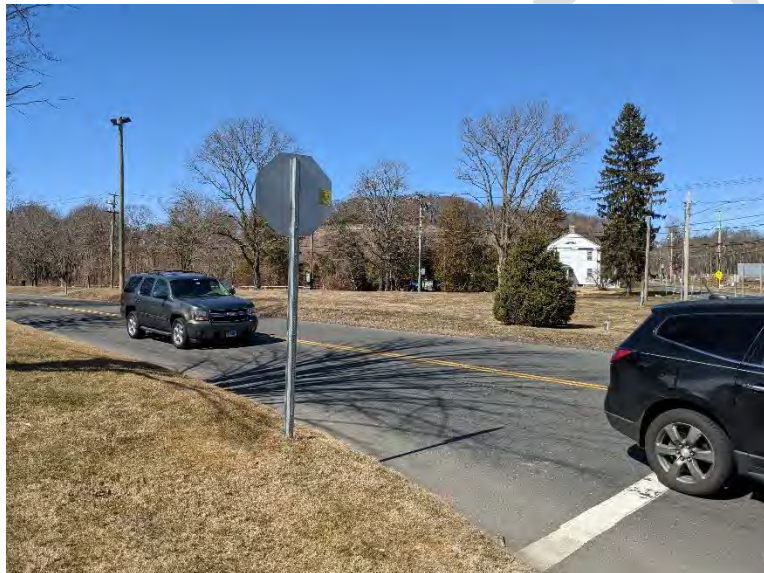
Figure 8: Stop sign at Center Road/Sport Hill Road intersection

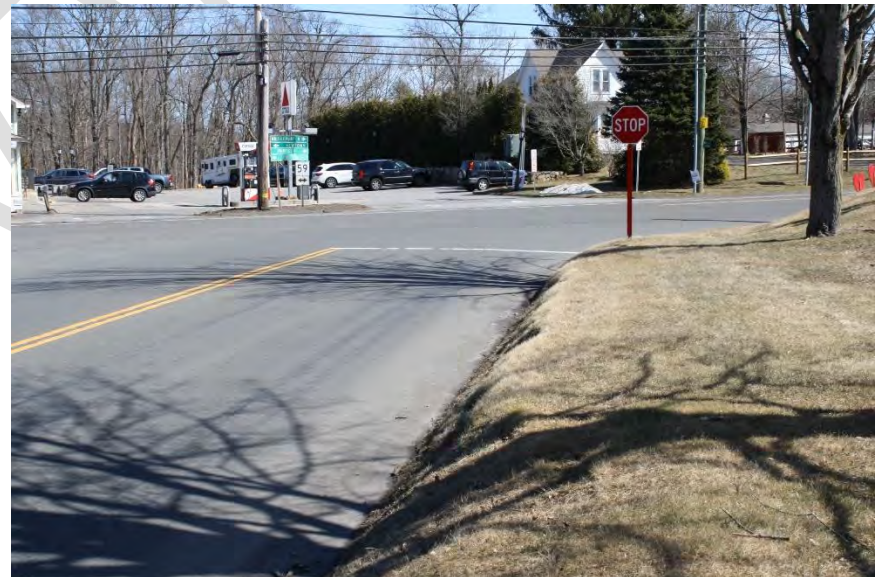
Figure 10: View towards driveways at Easton Village Store

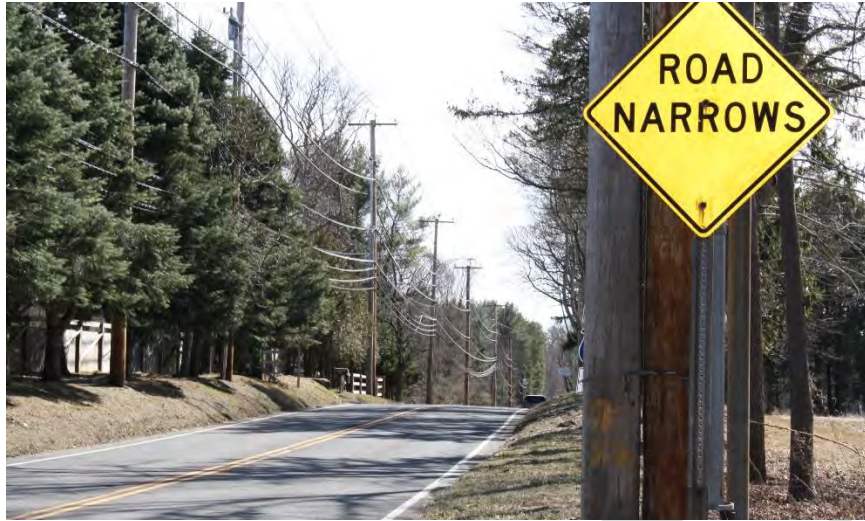
Figure 11: Narrow section of roadway on Sport Hill Road

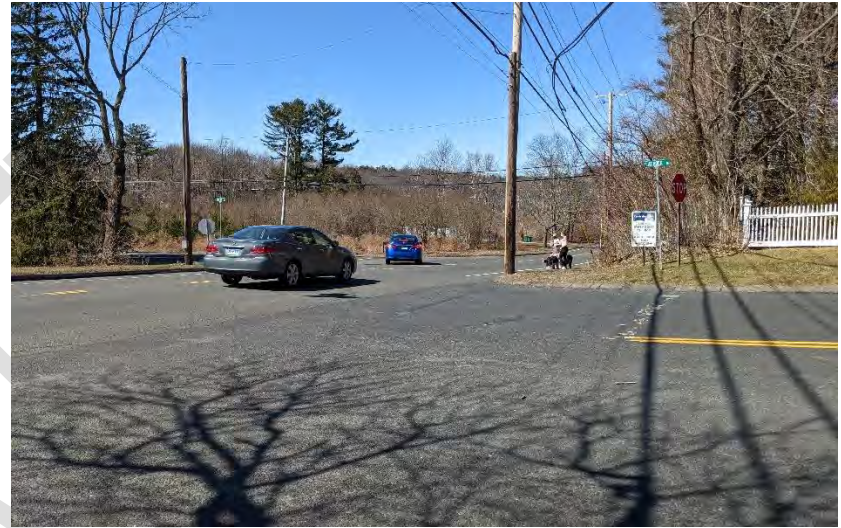
Figure 13: Sport Hill Road at Flat Rock Road

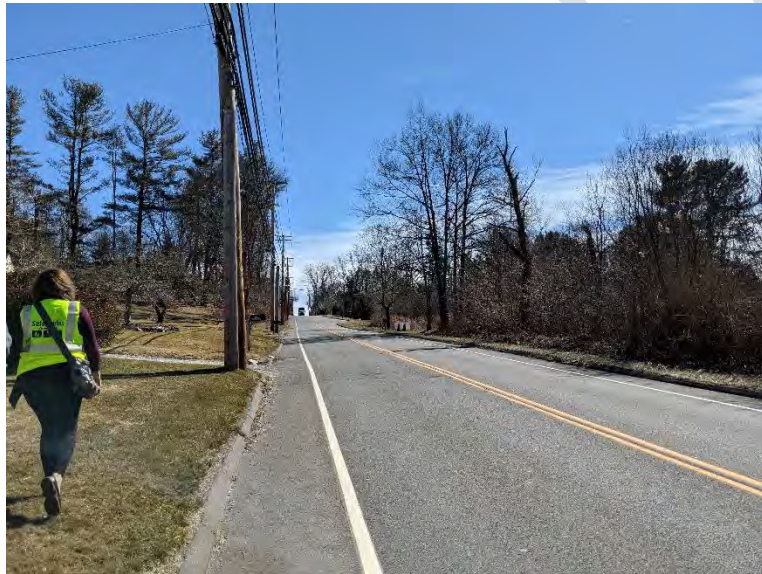
Figure 12: Sport Hill Road
