Confidential Inspection Report

22 South Park Avenue
Easton, CT 06612

July 20, 2022

Robert Camarda
Cornerstone Home Inspection

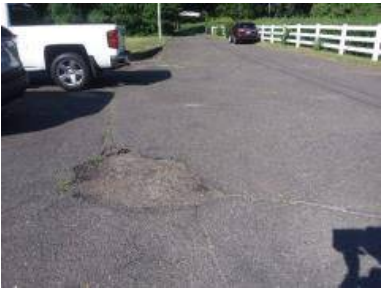
The driveway material consists of asphalt. The driveway is old and worn, and needing attention (seal coating, crack repair, etc.) in the short term. We recommend that you budget to replace it over time.

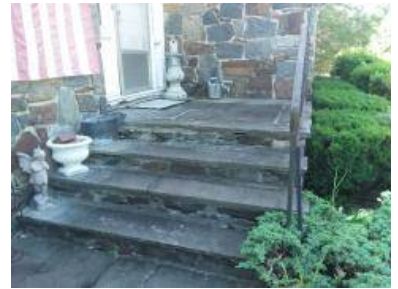
Stairs in front are made of concrete, flagstone, and stone. Some deterioration was observed, and attention will be needed. The riser heights or tread depths are irregular, and there is a greater risk of tripping with less uniformity, and especially with unconventionally high steps. Loose steps were found. The hand rail is deteriorated. It should be repaired or replaced. The handrail is loose. We recommend improvement. The guardrail is too low. We recommend improvement for safety.

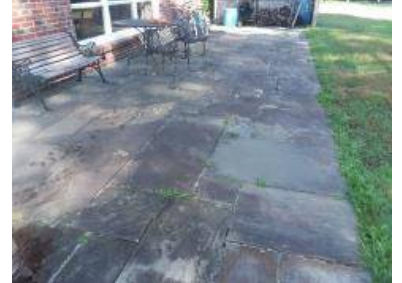
The patio type and materials include concrete and flagstone. Typical cracks were found. Irregular surfaces and settlement were observed - possibly from poor drainage, frost heaving, or inadequately prepared substrate.

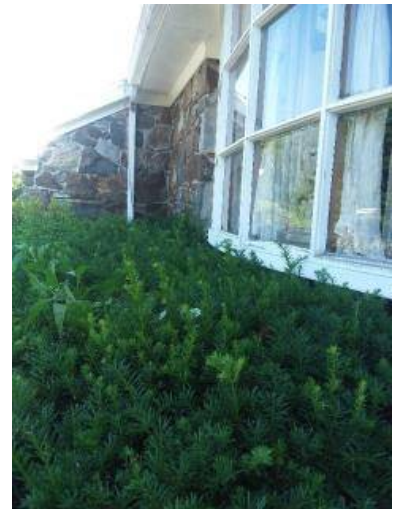
Shrubs are too close and touching the siding. Keep plantings trimmed away from structure.

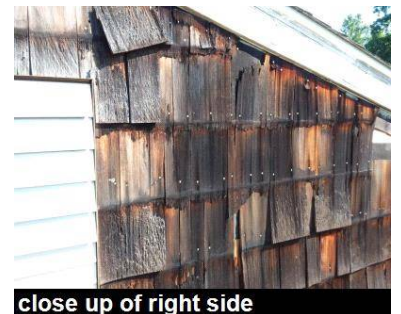
close up of right side

Much of the siding is worn and damaged.

We recommend replacing the siding and much of the trim. The masonry and mortar need to be touched up.

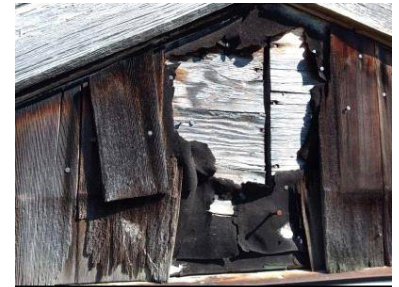
more siding damage on right side

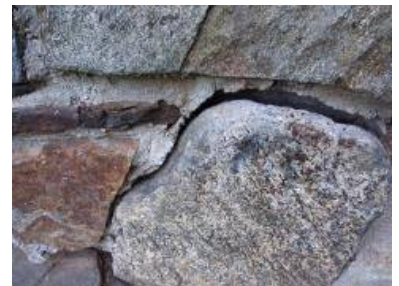
Some common cracks were found.

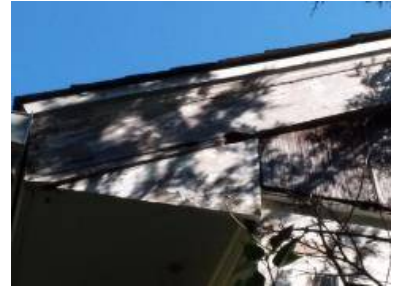
Damage that might be from woodpeckers was observed.

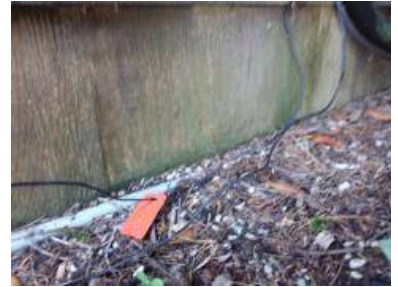
Earth-to-siding contact was observed. The siding should be a comfortable distance from the soil or mulch (6" or more is ideal). Close contact with the ground increases the likelihood of deterioration or wood-destroying insect infestation.

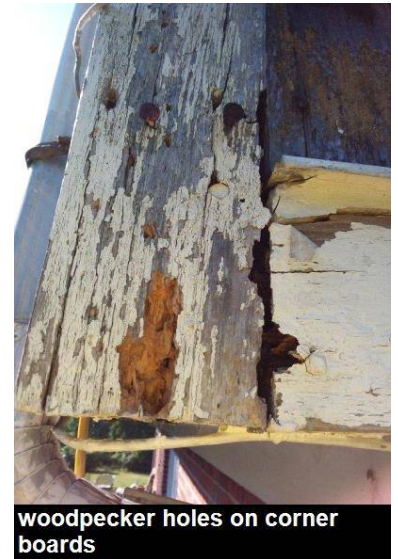
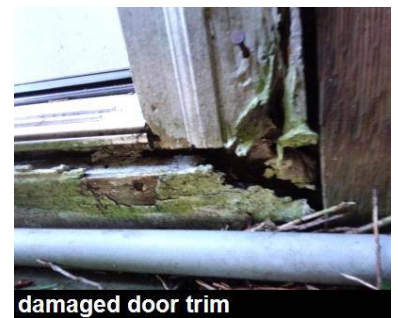
The trim materials include wood. Some deterioration was observed. We recommend that you replace deteriorated sections with new or pressure treated wood, or composite material; then seal and paint. Chipped, worn, or peeling paint was observed. Painting and finishing are recommended.

more deterioration around porch

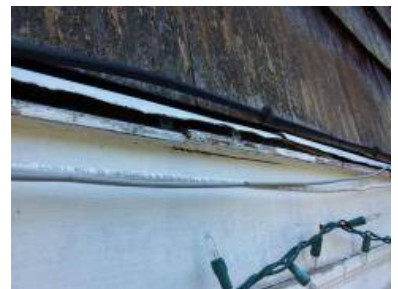
There is damaged or improper flashing over various trim pieces. This may allow water seepage into that area and can lead to damage.

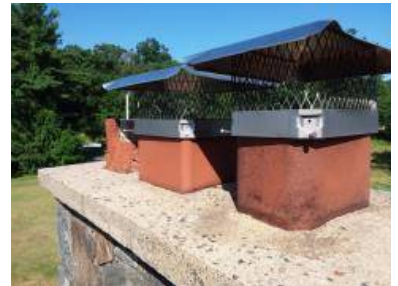
The flues were not visible because cap are installed over them that blocked our view.

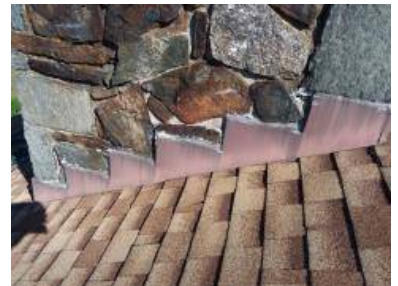
- OK MM RR
☒ ☐ ☐ The visible flashing around the chimney stack is serviceable. Monitor and maintain seals at all junctions.

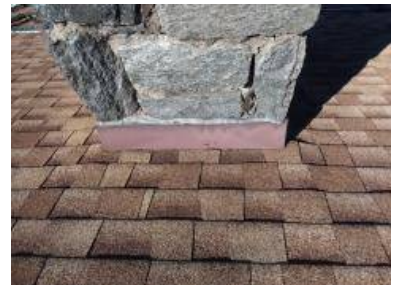
- ☐ ☒ ☐ We recommend adding a cricket behind the chimney to divert water around it in an effort to avoid leaks in the future. This is best done during your next re-roof.

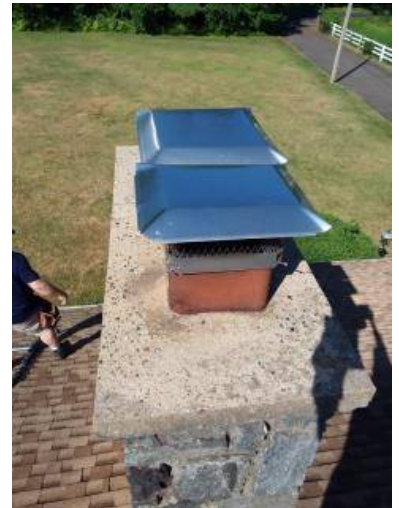
The chimney crown or cap is made of concrete. Its function is to keep water from entering the stack and causing deterioration.

The crown is in satisfactory condition with minor cracks. Some attention is needed.

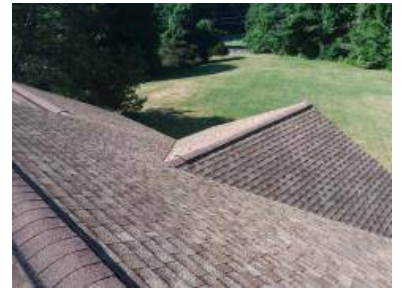
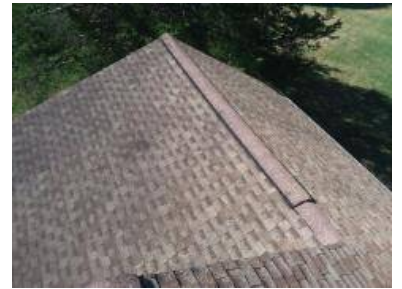
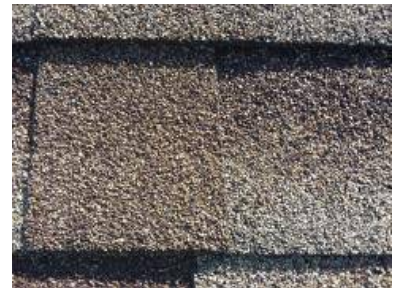
The roof is covered with one layer of asphalt composition shingles (fiberglass mats impregnated with asphalt). The roof appears to be beyond mid-life. The roofing material appears older, worn and weathered. It is dry and has lost much of its flexibility. It is still serviceable at the moment but should be monitored closely and you should budget for replacement over time.

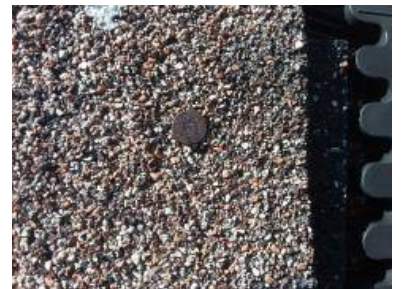
Exposed fasteners or nail heads should be covered with sealant.

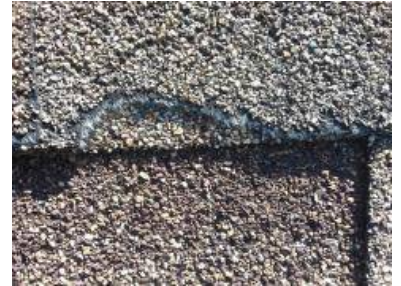
Damage, deterioration and/or defects are noted.

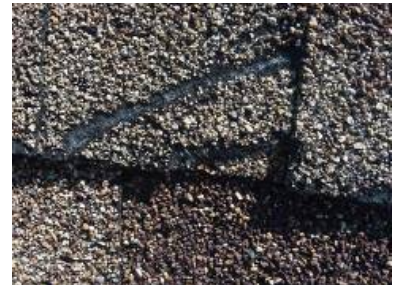
There is some surface damage and gouges, that are probably from snow and ice removal tools. Minor patching may be needed.

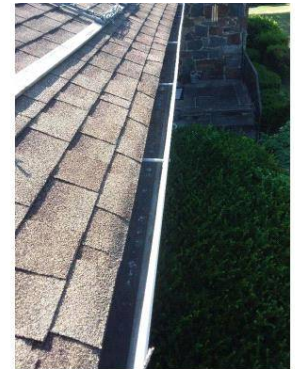
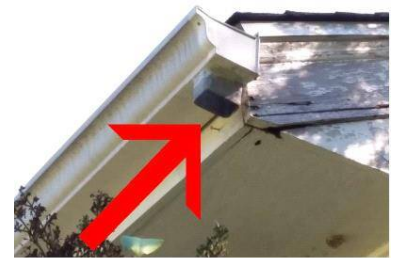
missing downspout

- ☐ ☒ ☐ Damage/Defects noted. There are missing downspouts. Improvement is recommended.

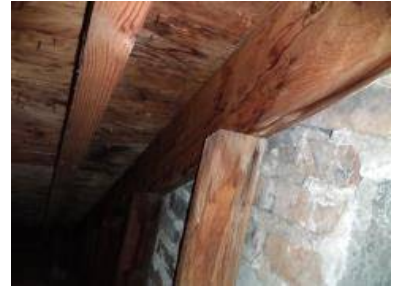
Some staining was observed around the chimney and this is commonly found in the majority of homes we inspect. Stained areas should be monitored and corrections/repairs made if moisture intrusion continues. Though inspecting for rodents is outside the scope of this inspection, evidence of prior rodent activity was observed. We suggest cleaning where needed, and you may wish to have treatment carried out by a licensed exterminator.

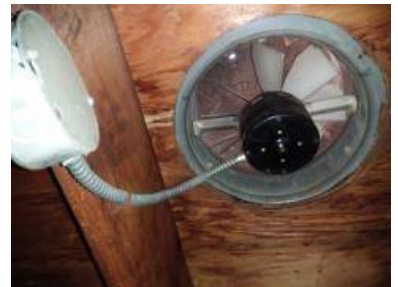
The attic is venting via the gable ends. A thermostatically-controlled exhaust fan is installed. The fan is not functional and should be removed or replaced.

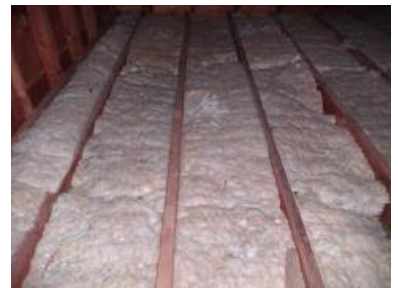
The types of insulation in the attic include fiberglass batts. The insulation is installed over the ceiling below. The insulation is older and was relatively thin (by today's standards) when originally installed, and now it has lost much of its body with age. Upgrading the insulation coverage should improve the comfort and heating fuel economy of your home.

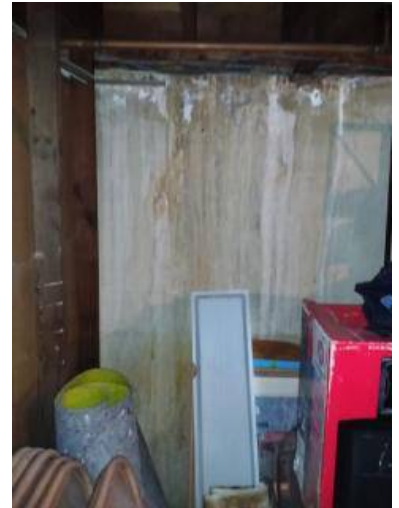
The walls are made of poured concrete. The walls are only partially visible because of basement finishing and or stored items. Re-inspect upon your walkthrough.

- ☐ ☒ ☐ Common cracking was found. We recommend sealing the cracks to prevent moisture intrusion, documenting them with photographs, and monitoring them over time. If movement continues and the cracks widen to a great degree (3/8" or more), then we recommend further evaluation and repairs by a qualified contractor.

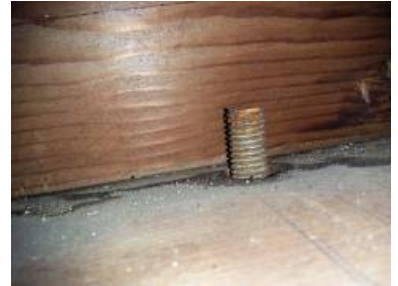
This inspection noted the presence of foundation bolts or straps used to secure the framing to the foundation. These fasteners are used to secure the home to the foundation, and provide resistance against movement from wind, flooding (where applicable), and earth quakes. Nuts were not threaded onto the bolts, however.

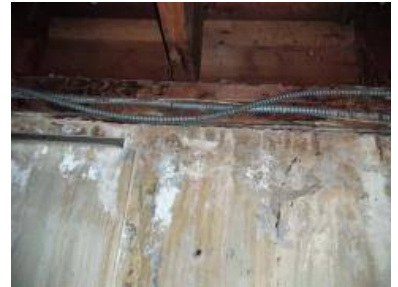
- OK MM RR
☐ ☒ ☐ Signs of moisture include water stains. They are dry at this time. Monitor and take action if needed. Some measures you can take to minimize further moisture intrusion are rerouting ground and roof runoff and improving or modifying the grade around the house. If moisture issues become unmanageable, we recommend you contact a basement waterproofing company for repair options. At a minimum, we routinely recommend running a dehumidifier (seasonally) to help reduce ambient moisture in most basements.

A waterline about 35" off the floor was observed around the entire basement. Stains of only a slight amount of water were also found. If this flooding occurred from outside water then what remedies have they implemented to prevent future occurrences? If the problem has not been adequately addressed then it seems almost certain that the area will flood again.

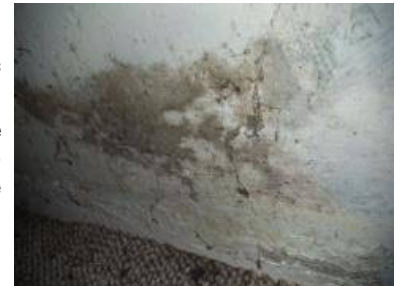
Mold-like spots and or discoloration are observed. We are not mold experts and inspecting for and identifying mold or mildew is outside the scope of this inspection and beyond our qualifications. Note that molds, mildew, or fungi may cause irritation to some or become a major health issue to others. Mold/fungal growth can also deteriorate organic materials including lumber or wood-based structural components. The first course of action should be to find the source of the moisture and stop it. Then depending on the extent of the stains it is recommended that you either clean the area or have the affected building material removed by a professional.

A mold-like patina was noticed on the lower part of the door in the basement.

For more information please refer to the EPA's website: Mold Cleanup in Your Home. This can be found at: <https://www.epa.gov/mold/mold-cleanup-your-home> and/or contact an industrial hygienist, or an occupational physician.

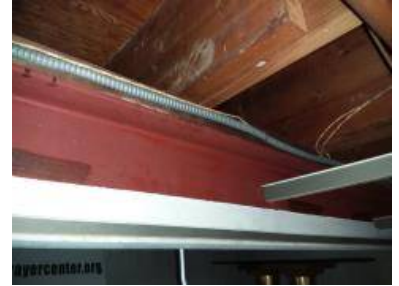
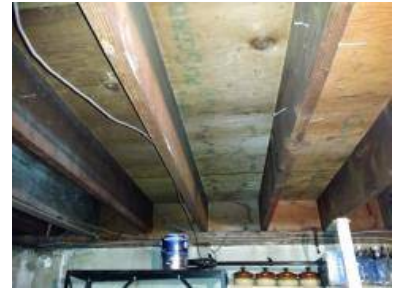
There is evidence of and damage from termites in several places in the basement. Some dead swarmers were also observed. We recommend further evaluation by a qualified contractor to repair, reinforce or replace any damaged wood, and that you consult with a qualified exterminator.

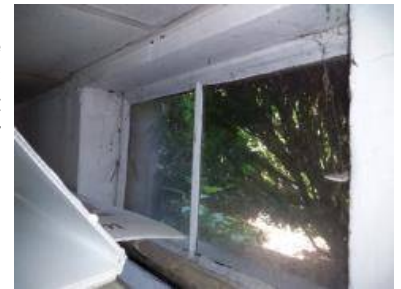
There are basement level windows. Basement windows have single glazing (panes) and are a basic functional design, but they are not very energy efficient. Consider upgrading them.

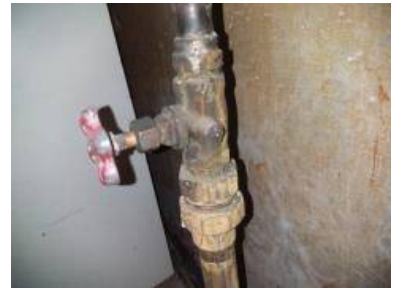
The main shutoff valve is located in the basement. The valve was not tested. The main valve is an older gate valve and is not as reliable as a newer-style ball valve. Consider replacing it.

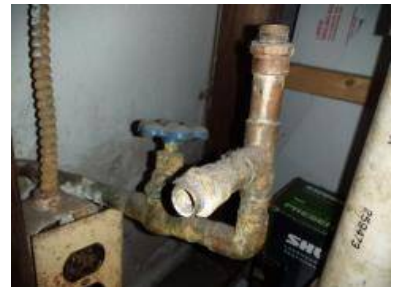
There are open-ended pipes in the basement. Although a valve is upstream of the opening and we do not see any leaks, we recommend the ends be capped to reduce your risk of leaks in the future.

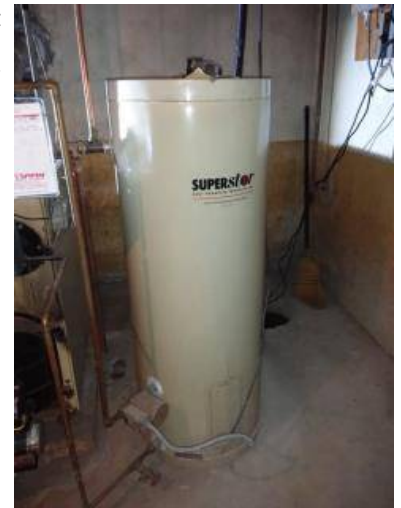
☐ ☒ ☐ The hot water storage tank is 23 years old with an expected life of approximately 15 to 20 years. Budget for replacement.

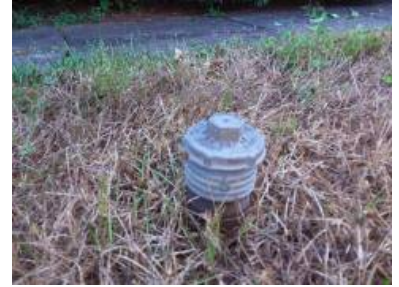
The type of fuel used for heating is oil. A fill pipe was observed in the yard, and this is evidence of a buried heating oil tank. Research is needed to determine the status of the oil tank. Generally, we recommend buried steel heating oil tanks be removed or properly abandoned, and an environmental report indicating a satisfactory soil contamination level (below 500 ppm) be given to you prior to closing.

Another buried fuel tank might be on the property as they sometimes are with farms.

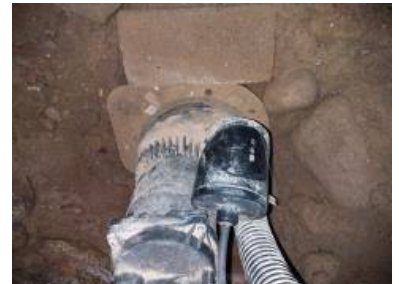
A sump pit and a pump are installed. There is no water in the pit and so the pump cannot be fully tested, nor can we determine the adequacy of this de-watering system. If it does not effectively control water intrusion into this area then a redesign and implementation is needed. Consider augmenting protection by adding a second sump pump, and attaching a battery backup or installing a power generator. Also

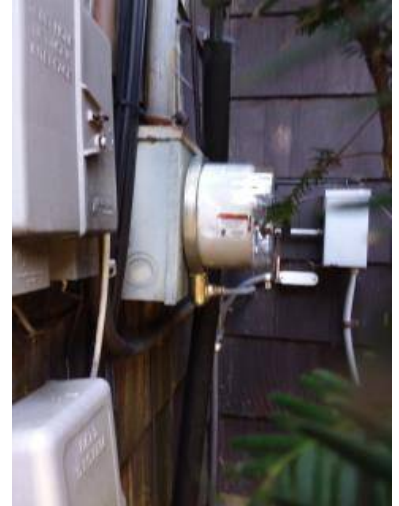
The service entrance cable is overhead. The main disconnect is located at the panel. The total amount of current is 100 Amps. The service may be insufficient by today's standards. Consider upgrading. The service can provide both 110 and 220 Volts. The panel(s) contain circuit breakers.

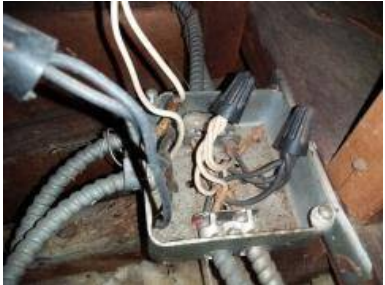
The branch wiring is copper. Wiring methods being used: Non-metallic sheathed cable (Romex) and armored cable (BX) and or plastic conduit. Open junction boxes were found in the attic and in the basement. We recommend installing covers for protection.

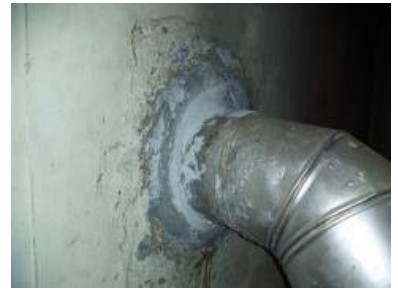
- ☐ ☒ ☐ The flue pipe is metal that enters a masonry flue. The draft regulator is screwed shut and not functioning as it was intended to. It might have been done for a good reason (the system might run more efficiently this way). Ask sellers for service history, otherwise have it reevaluated by your technician.

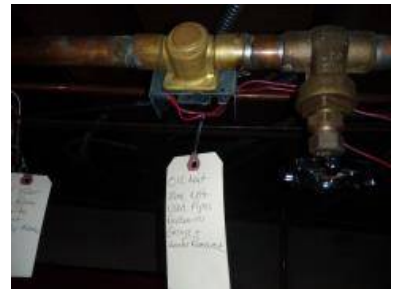
- OK MM RR
☐ ☒ ☐ The 2nd zone for heating the garage has been disconnected. The house has 1 zone. The thermostat was tested and works.

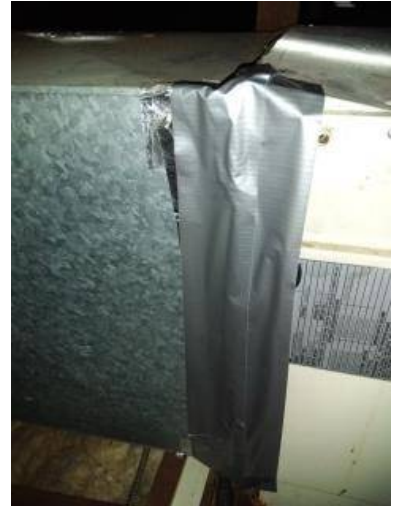
The filter slot is covered with tape, so filter was not accessible and not inspected.

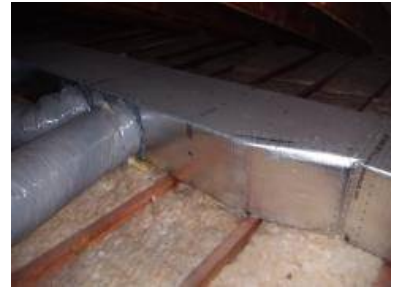
- OK MM RR
☐ ☒ ☐ Duct types include insulated and or non-insulated sheet metal, flexible round, and fiberglass duct board ducts. There is much discussed and published on the internet about fiberglass duct board. Some say that fiberglass particles from the inside of the duct can become airborne and can be blown into the living space. However, in 2018 a product manager at Johns Manville told us that there is no scientific evidence supporting claims of product inferiority or danger. This was backed up with about 100 pages of test documents (white papers). We recommend that you consult with an HVAC specialist or contact one of the material manufacturers: Certainteed, Owens-Corning, 3M, Johns Manville, etc.

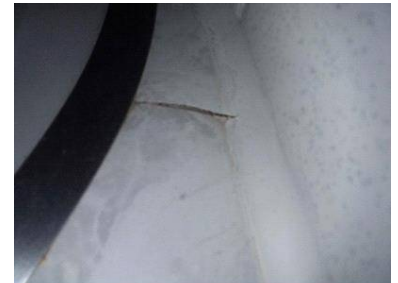
Damage was observed at the countertop.

Formica is cracked and delaminating

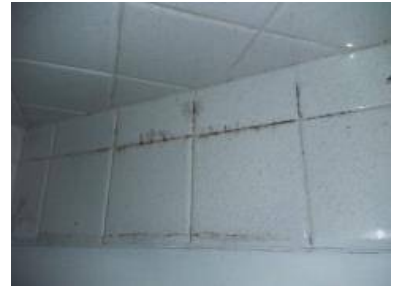
We recommend installing an exhaust fan.

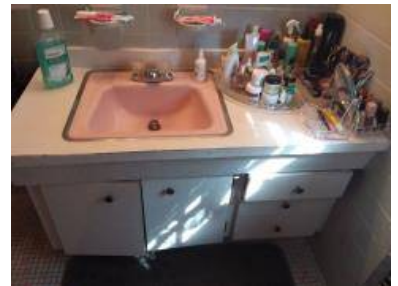
The sink or fixture is worn or otherwise inferior. You should consider replacement. The faucet is working ok. The drain stopper did not operate properly or at all. Some damage is observed at counters/cabinets. Budget for repair or replacement.

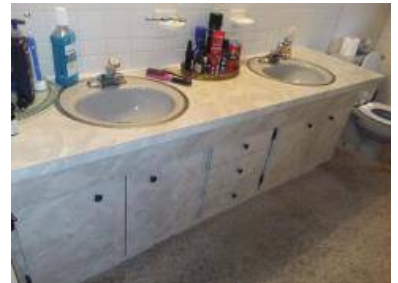
The sink is cracked or damaged. We recommend replacement. The faucet is working ok. The cabinet is in serviceable condition.

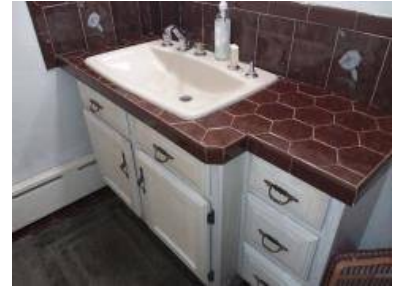
The sink or fixture is worn or otherwise inferior. You should consider replacement. The faucet is working ok. The counter and cabinet are in serviceable condition.

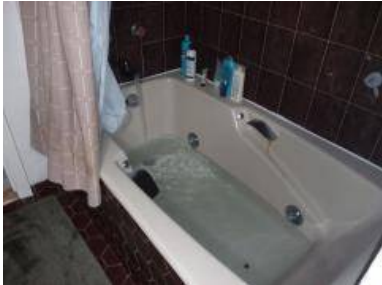
- ☐ ☒ ☐
- Damage noted to bathtub. Consider replacement. The faucet is serviceable.

We were told that the hydro-spa is not functional. Once running, sanitization is recommended. Its supply pipes should be flushed with an anti-bacterial cleanser (bleach or white vinegar) periodically. There was no access to the hydro-spa mechanicals, and this would be inconvenient when service is needed. The showerhead is working as it should.

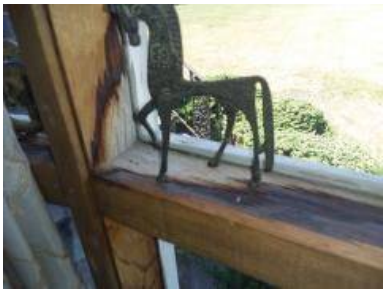
OK MM RR
☐ ☒ ☐ Stains are noted on the inside of the living room window.

Moisture stains in the living room.

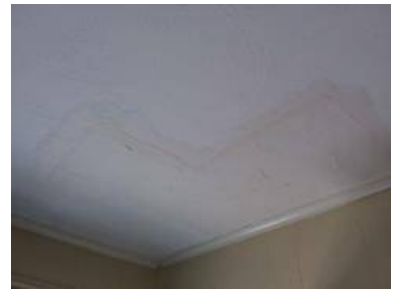
- OK MM RR
☐ ☒ ☐ Some patching was observed in the corner of this room.

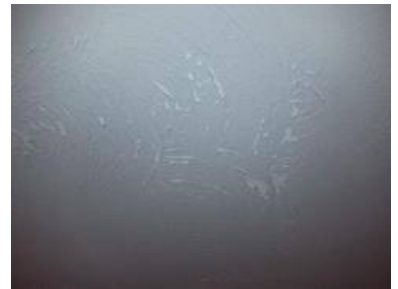
Primary Bath:

Irregularity and peeling paint were observed at the ceiling. This is probably caused by humidity. We recommend installing an exhaust fan.

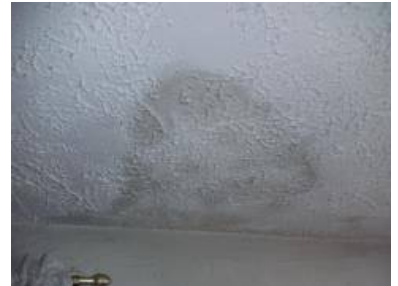
Guest Bath:

There is a condition in the ceiling that needs attention. Staining was observed.

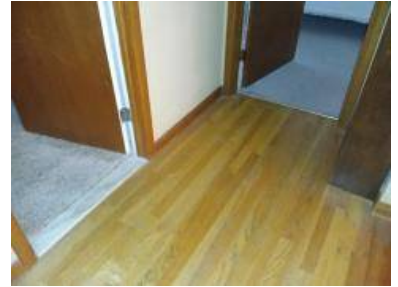
- ☐ ☒ ☐ Flooring materials consisted of wood, carpet, tile, and a laminate. Unevenness or slight slope was found in spots. Floor squeaks were observed. Stored items or furnishings prevent full inspection. Rugs and floor coverings prevent viewing of primary floor materials in some areas.

- OK MM RR
☐ ☒ ☐ Cracked tiles were observed in the entryway.

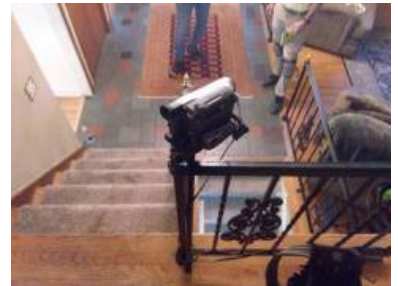
Stairs & Handrails:

Interior stairs are serviceable. The handrail is improper - it does not return to the wall and could catch on clothing. and The guard rail at the top of the stairs is too low by today's standards. We recommend improvement for safety.

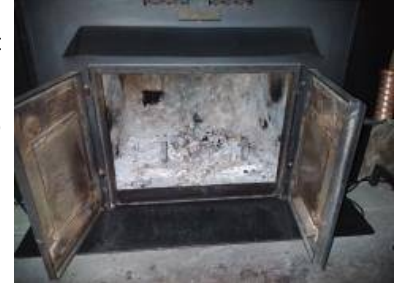
A wood stove is installed in a fireplace in the living room and so the inside of the firebox or throat is not visible. Check with the Town for permits, and refer to the manufacturer's operating instructions and maintain required clearances to combustibles. If no permit was filed, we recommend further evaluation by a qualified specialist prior to use.

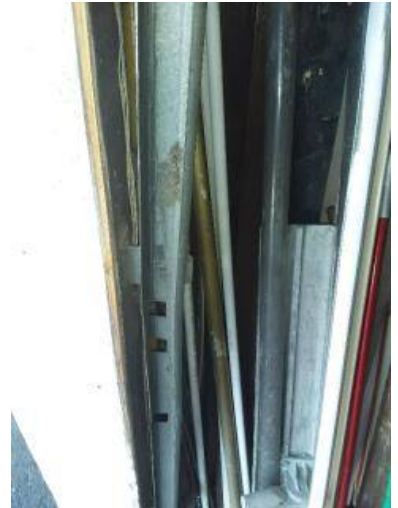
Garage Door:

The garage doors are made of wood or composite. Safety springs are installed. Moderate wear and tear were observed. The doors are working but in worn, tired, or slightly damaged condition. Maintenance should be administered in the short term (tightening/upgrading hardware, lubricating moving parts, etc.). Budget for repairs now, and replacement over time. Adjustment or service is needed. The hardware/door(s) is older and worn, and the system(s) need adjustments, lubrication, and or service. The weather stripping is damaged. We recommend replacing it.

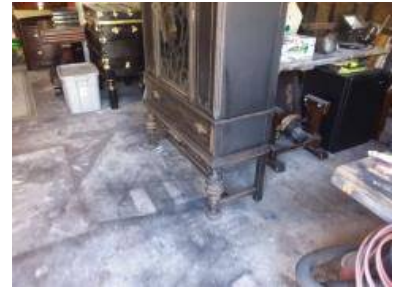
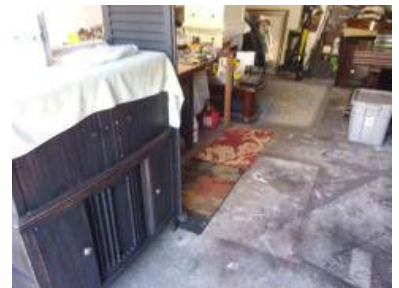
- OK MM RR
☐ ☒ ☐ Common cracks were found. Visibility was limited due to stored items and cluttered conditions in the garage. We recommend re-inspecting the garage again during your walkthrough. The visible parts of the floor are in serviceable condition.

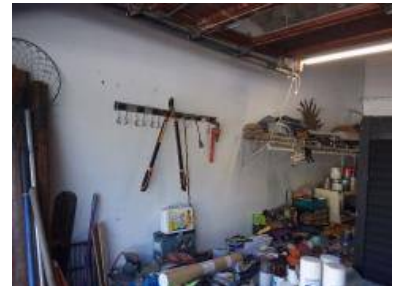
Interior Walls:

- ☐ ☒ ☐ The wall material(s) consist of drywall and concrete. Some damage was observed. There is moisture damage at the bottom of the center or side post(s).

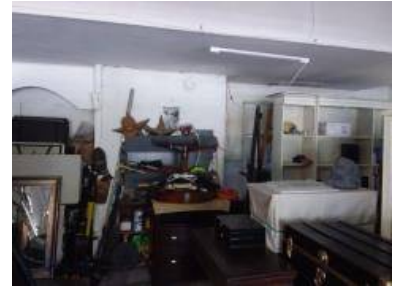
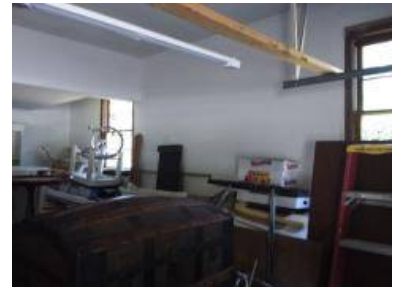
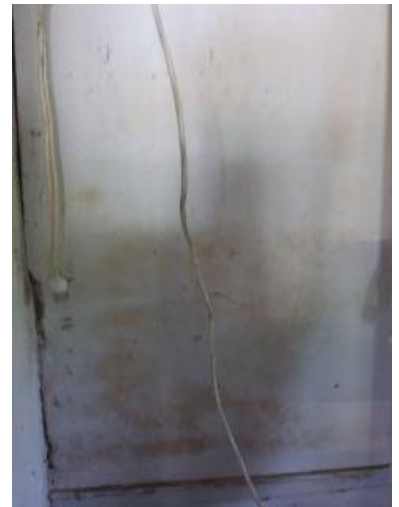
Signs of a previous water leak were found - stains. The stains are dry now, so it cannot be determined if there is active leaking. We suggest that you inquire with the owner, and/or monitor the area and take appropriate action if needed.

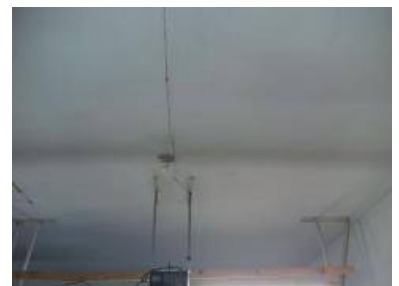
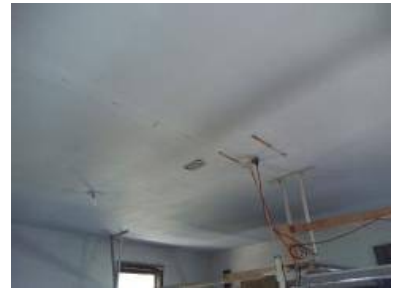
Ceilings:

Based on the ceiling stains we presume that there have been water leaks from above. The stains are dry now, so it could not be determined if there is active leaking. We suggest that you inquire with the owner, and/or monitor the area and take appropriate action if needed.

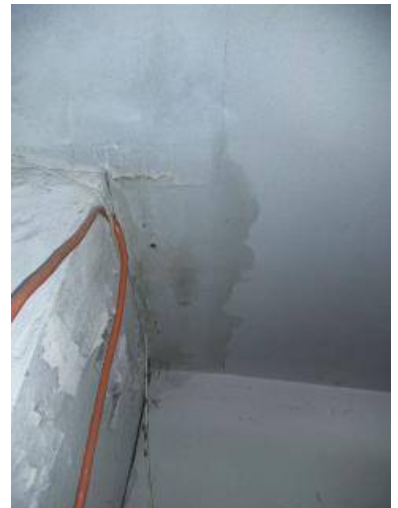
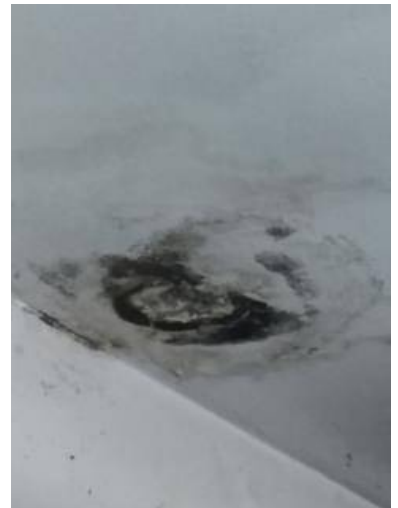
Mold-like spots and or discoloration are observed.

Note that mold may be an irritant to some or a major health issue to others. It can also deteriorate organic materials including lumber or wood-based structural components. The first course of action should be to find the source of the moisture and then stopping it. Then depending on the extent of the stains it is recommended that you either clean the area or have the effected building material removed by a professional.
