Examples of Volunteer Restoration Work (2010)

Center Street Cemetery (c. 1860)

Thomas Barlow (Before and After)

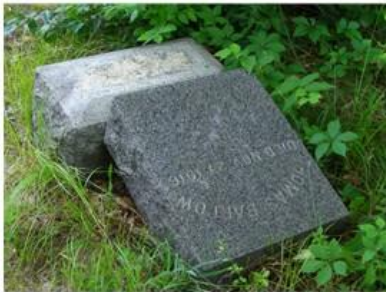
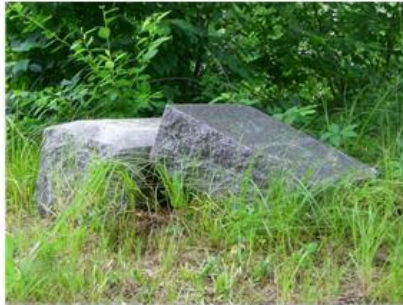
Tombstone was found near the outer edge of the cemetery closest to the water's edge. The stone had been knocked over and was facing in the wrong direction. Stone restoration involved lifting the stone via tripod, turning it around and using monument compound and epoxy to reset the tombstone.
